REPAIR AND STRENGTHENING OF EARTHQUAKE DAMAGED HOUSES IN MAHARASHTRA

Central Building Research Institute, Roorkee (U.P.)

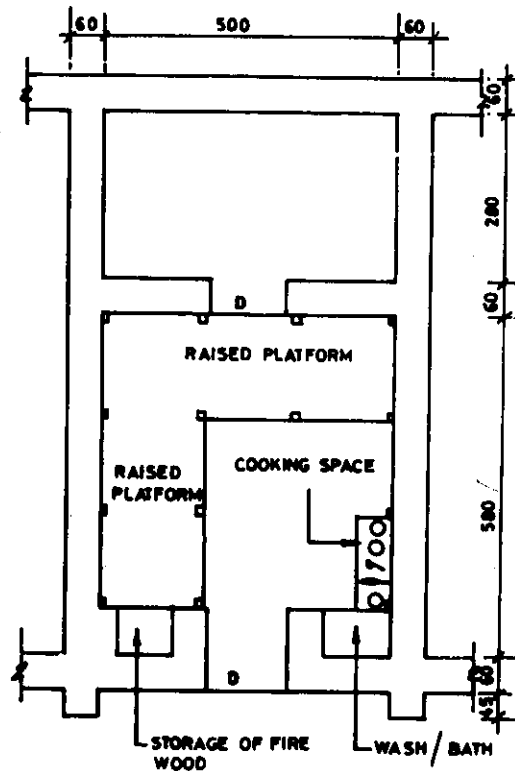
Fig.1 TYPICAL PLAN OF A HOUSE IN LATUR DISTRICT

A typical plan of a common house with two rooms is shown in Fig.1. The plinth of the house is about 45cm high. The entrance and right side of the front room are at plinth level, while the rest of the area of the house was raised to a height of about 90cm above plinth. An incremental concept of housing had been adopted, with addition of rooms in stages, as per owner's requirement.

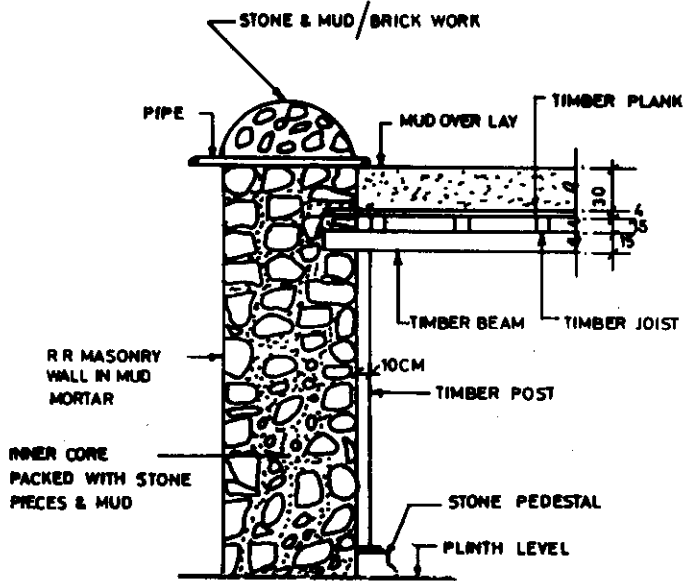
Fig.2 SECTION OF WALL AND ROOF

Some of the walls were fully load bearing while others were partially load bearing with part of the roof load carried by vertical timber members provided adjacent to the wall. Cross section of the load bearing walls used in most of the common houses is shown in Fig.2. The walls were 60 to 100cm thick made of irregular/round shaped stones in mud mortar. In a few of the houses, walls upto 160cm wide were seen. In some houses, flat flaky stones were also used for constructing walls. The walls were made of an outer and an inner wythe and the inner core was packed with small size stones and mud mortar. In some villages in Solapur District, locally available soil containing silt, sand and pebbles and lacking in clay content, had been used for mortar and filling the

inner core. Its binding property was very poor and cannot be categorized as mud mortar as it lacked in clay content. No through stones were provided to tie the inner and outer wythes of the wall together. Thus, the quality of construction of the walls was extremely poor. Many of the walls were built out of plumb.

The plinth and foundation were also built similar to the cross section of wall shown in Fig.2. The thickness of foundation was equal or 20 to 30cm more than that of wall and in areas having shallow depths of black cotton soil, the foundation was taken to hard strata below the black cotton soil. In areas having deep deposits of black cotton soil, the foundation was taken upto 3.6 to 4.5m depth.

The roofs (Fig.2) of some bigger houses usually owned by the higher income group of the villagers consisted of wooden beams of size about 15X20cm laid at a spacing of 1.2 to 1.3m c/c with wooden joists of 7.5X10cm section provided over the beams at a spacing of 20 to 30cm c/c. Planks of Mango or inferior quality timbers about 4cm thick were laid over the joists. An overlay of earth about 40 to 75cm thick was placed over the timber planks. Parapets upto 60cm high were made around some of the houses in RR masonry in mud mortar. But in many cases, no parapets were provided, but the top of wall was rounded off with a layer of soil and pebbles, with provision of drain pipe as shown in Fig.2.
