CASE STUDY OF KOYNA DAM*

J. KRISHNA¹

Introduction

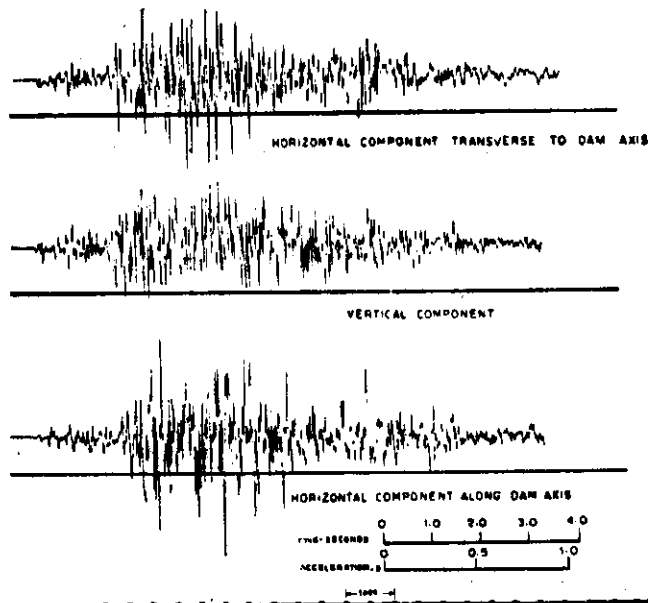
Fig. 4 Accelerogram recorded at block 1-A of Koyna dam on December 11, 1967 at 04-21 I.S.T.

The accelerogram (3) recorded in the dam is shown in Fig. 4, and the response spectra in Figs. 5, 6 and 7 for the three components. For this shock, near its epicentre, spectral intensities indicate that vertical component of ground motion is as intense as the horizontal components. Comparing with other strong motion records, though peak ground acceleration is larger at Koyna, its spectral intensities are smaller. They are shown in Table 1 and a comparison of their values with other shocks in Table 2. It will be seen that inspite of the big peak of acceleration, spectral intensity of Koyna earthquake was much smaller than those of El Centro and Olympia shocks. The accelerogram indicates higher frequency

ground motion than has been common for past recorded earthquakes. For example, the peak Koyna acceleration of 0.63 g is associated with an average zero-axis width of 0.05 seconds, to give a pulse area of approximately 15 cm/sec, whereas the El Centro earthquake of May 18, 1940 (N-S) had a peak acceleration of 0.33 g, a zero-axis width of 0.23 seconds, and hence a pulse area of approximately 37 cm/sec. The damage potential of the Koyna shock was, therefore, not great.

The accelerograph was located in a monolith of the dam, which was very close to the abutment. The gallery housing it was just a little higher than ground motion itself and has not been materially influenced by the characteristics of the dam (4). While analysing the response of the dam, the accelerogram has been taken as the ground motion.

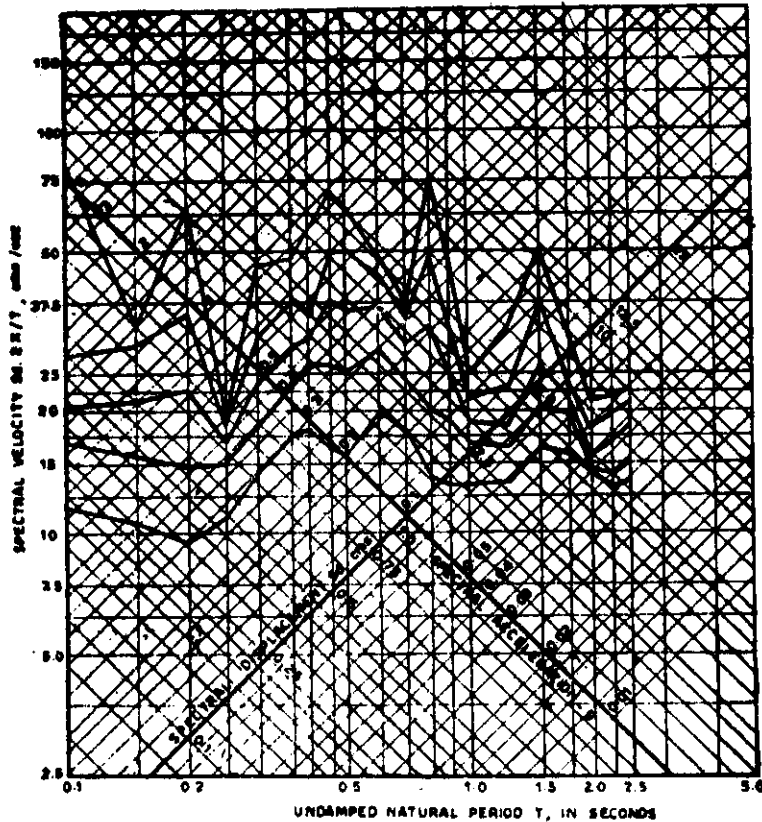
Fig. 5 Response spectra for transverse component, the curves are for 0, 2, 5, 10 and 20 percent damping

The maximum ground velocity of the longitudinal component is 24.19 cm/sec and is nearly equal in value to 25.58 cm/sec of the vertical component. The transverse component has a smaller value of 20.08 cm/sec. The maximum ground displacement is the smallest for the longitudinal component and the maximum for the vertical component. The values of ground displacement are 13.30 cm, 21.64 cm and 28.84 cm corresponding to longitudinal, transverse and vertical components. The peak displacements are obtained in the first waves. That emphasizes the importance of initial peaks of an earthquake wave.

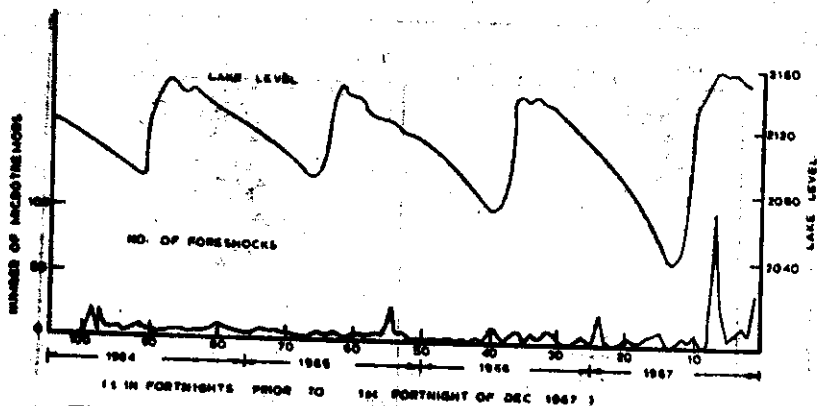
Fig. 8 Lake level and number of foreshocks 1963 - 1967
(After Guha et al.)

up as shown in Fig. 1, and as the lake filled up, these stations recorded microtremors increasingly (see Fig. 8). Between 1964 and 1966 there was a swarm of microtremors but none exceeded magnitude 3.7 and their focus was estimated at 4 kms. They were probably induced by the lake. The question as to whether the foreshock of September 13, 1967 and the main shock of December 11, 1967 were caused by the same process or they were normal seismic activity of the hidden faults below the trap deposits remains unanswered. Figs. 10 and 11 show the depth distribution and location in plan of microtremors of magnitude greater than 3.
