## DAMAGE REPORT OF THE LATUR - OSMANABAD EARTHQUAKE OF SEPTEMBER 30, 1993

A. Sinvhal, P.R. Bose and R.N. Dubey  
Department of Earthquake Engineering,  
University of Roorkee,  
Roorkee, U.P., India, 247667.

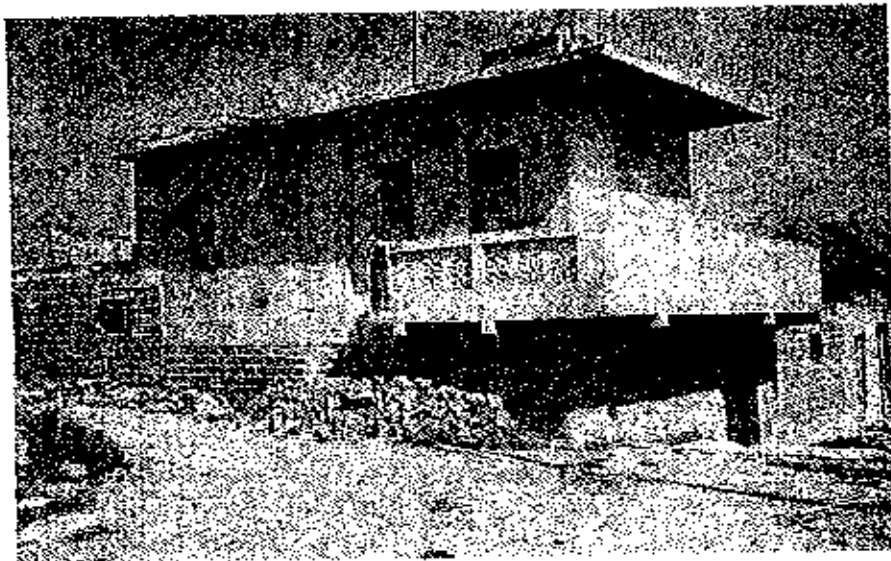
Rectangular blocks made of crushed stone or concrete are also popular as a building material. These are laid in cement - sand mortar. These houses performed rather well in the earthquake. Buildings which are made either of brick or stone block and are laid in good quality cement mortar usually had an RCC roof. Such buildings performed well during the earthquake, as shown in fig 11.

*Fig 11* Well constructed stone block masonry house survived the quake at Kawtha.

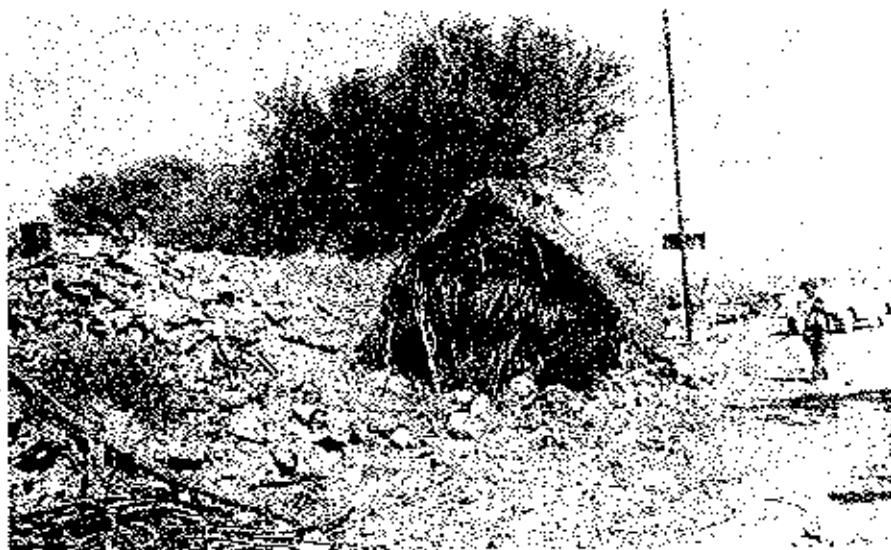
At the periphery of most villages houses are made of bamboo frames with thatched walls or reed coated with mud and a thatched or tin roof. These flimsy structures have survived the earthquake, figs 13 and 14, and no casualties were reported from these.

*Fig 13 Huts survived but heavy stone houses collapsed.*

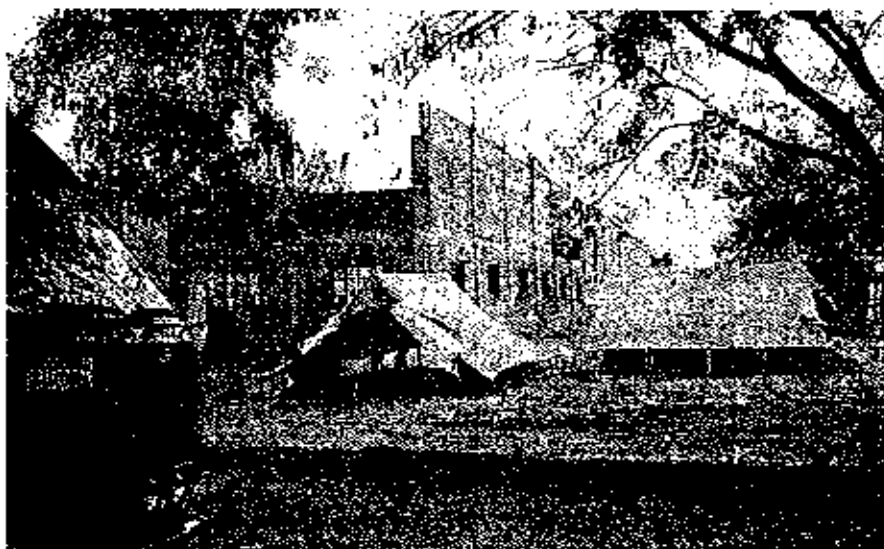
Reinforced concrete framed buildings in the area were either single or double storeyed. These and the ones which were under construction resisted the earthquake fairly well, figs 16 and 17. At Killari efficacy of earthquake resistant measures is proved very well, fig 18, brick masonry houses with cement sand mortar which used a lintel band, or vertical steel have withstood the earthquake. Mr. Kale, a primary school teacher built a brick house with lintel band at Killari on the advice of his brother who works for the building industry in Bombay. The house survived the earthquake with minor cracks. Ms Pushpa Rani's house was made with vertical RCC columns at joints and corners. It developed minor cracks only and is erect at Killari.

*Fig 17 Framed building under construction near the sugar mill at Killari, undamaged after the earthquake.*

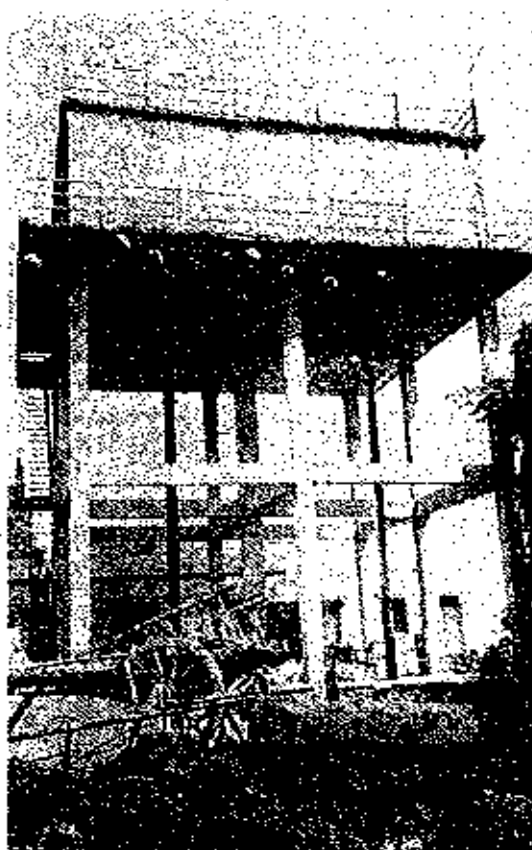
*Fig 29 Undamaged water tank at Killari.*

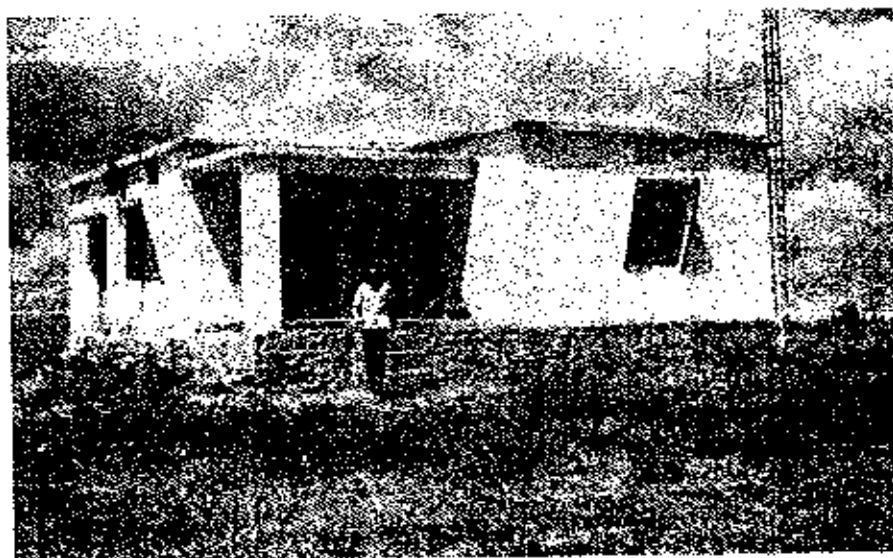
The central column of the Prakash Stambh outside the Renuka Devi temple and the sancum sancorum of this ancient temple collapsed completely, fig 45. A new idol has since been installed in the place of the old one. A heavy Kalash, (brass pot) almost 75 kg in weight, fig 46, fell off at a horizontal distance of about 8.25 m from a height of 10 m. The mosque and mazar complex is of a later date and 2 minarets partially collapsed due to the earthquake, fig 47. Plaster fell off the dome and vertical hair line cracks appeared in the mazar of Peer Pasha. The wireless station is a well engineered structure, fig 48 and remained intact in wake of the earthquake.

*Fig 48 Intact wireless building on hillock at Kharosa.*
