## **SEISMIC RESPONSE OF A TWICE-RETROFITTED BUILDING**

### **ABSTRACT**

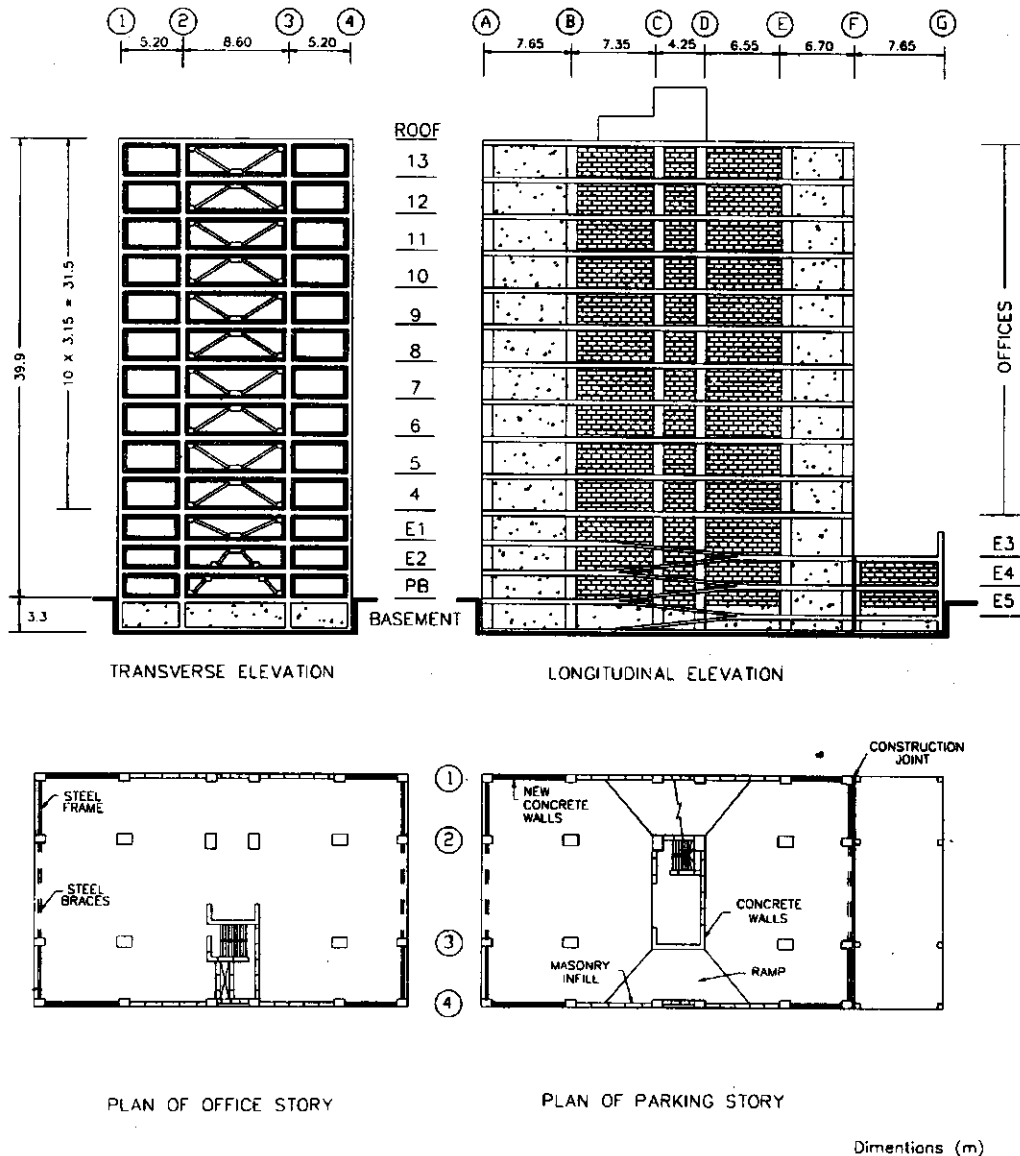
Fig. 1 Elevation and plans of building

Since it is located in the Mexico City area where the greatest damage was observed during the 1985 earthquake, and because large vibrations are expected due to its flexibility, the Jal building was selected among 50 candidates for study. This was built in 1981 using the Mexico's Federal District Constructions Code (RCDF, 1976). It is a 14-storey reinforced concrete structure occupied by offices, except for the first four stories, which are used for parking. The building has a small three-level adjoining structure, separated by 150 mm from the main structure and attached at the base. Originally the structure consisted of a waffle flat-plate (450 mm thick) on rectangular columns with a box-type masonry wall around the staircases, a small core of concrete shear walls around the elevator shaft, and masonry infill walls in the end frames of the longitudinal direction (L). The detailing of the reinforcement does not comply with present requirements for ductile structures, especially regarding the transverse reinforcement in columns and in slab-column joints. Figure 1 shows a schematic view of the structure.

In the 1985 earthquake, the JAL building suffered moderate structural damage which consisted of the bending and shear cracking of columns and severe shear cracking of masonry infill walls, especially above the seventh storey. The widths were smaller than 1 mm except in a few columns whose widths were greater

than 1 mm. Widespread cracking of the ribs of the waffle slab was also evident, revealing positive and negative yield lines. No appreciable settlement of the foundation was observed. It is convenient to point out that we did not inspect the building.

The building was then strengthened in 1986 by adding infill concrete walls in the L direction connected to the original structure only through the upper slab. The sections of the interior columns were jacketed with new reinforced concrete without any modification to the foundation (Figure 1). The masonry walls were merely covered with plaster, and the cracks of the slabs were not repaired.

The deficient behaviour of the structure observed as a consequence of the moderately intense earthquakes between 1986 and 1995 led the owners to make a second rehabilitation. This time, the building was strengthened in the transverse direction (T) by steel bracing which was attached in the central bay of the exterior transversal frame through an additional steel and reinforced concrete frame. These coupling frames were put on all bays of the transversal façades. The vertical members of these frames were attached by using steel bars welded to the steel plates and glued to the concrete columns with epoxy resin through perforations. The bracing elements were square box-cross sections formed with steel plates welded to the

new coupling frames. The bracing system consisted of continuous X-bracing across two stories (Figures 1, 2 and 4).

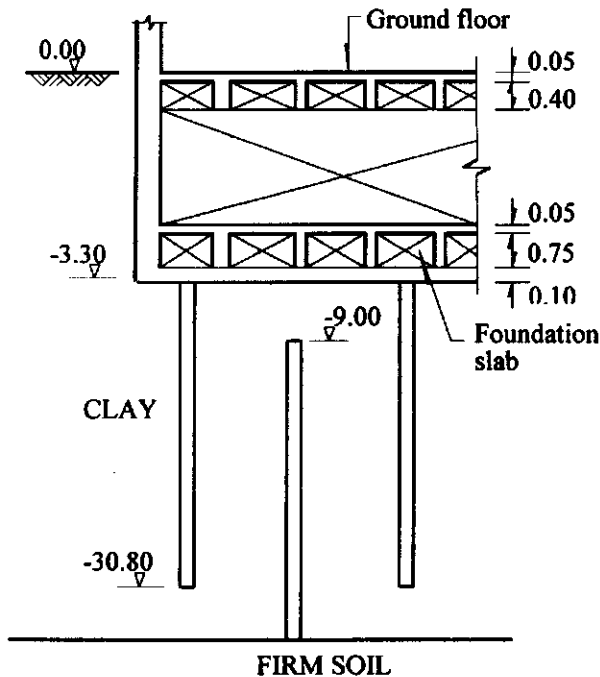
Fig. 2 Vertical cross-section of the building foundation

The foundation consists of a concrete slab on friction piles, driven according to a rather peculiar solution, as shown in Figure 2. The so called A-piles are fixed to the foundation slab and driven into the clay soil without reaching the firm layers. B-piles are driven down to the firm layer but are separated from the foundation. The weight of the building is assumed to be supported by the lateral friction of the piles and partially transferred from the A-piles to the B-piles, thus avoiding a foundation failure while at the same time allowing the building to sink following the areal settlement of the ground.

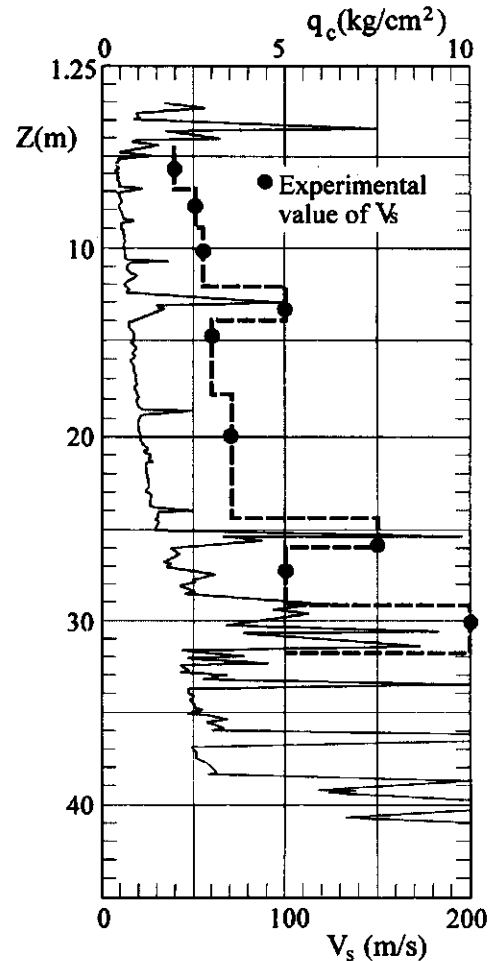
Fig. 3 Shear wave velocity ( $V_s$ ) profile and cone penetration resistance ( $q_c$ ) at the building site

front of it, where a field (surface) station was placed. Also, at the field site, a selective sampling and seismic cone testing (SCT) was executed. Figure 3 shows the soil profiles at the building site. In general terms, under a crust of about 5 m, the upper soft clay deposits extend to a depth of 29.5 m, followed by a 3 m thick intermediate firm layer. The lower clay layer extends from 32.5 to 38.5 m depth, followed by the so-called deep firm deposits. The shear wave velocity profile, determined from the SCT tests, is also shown in this figure.

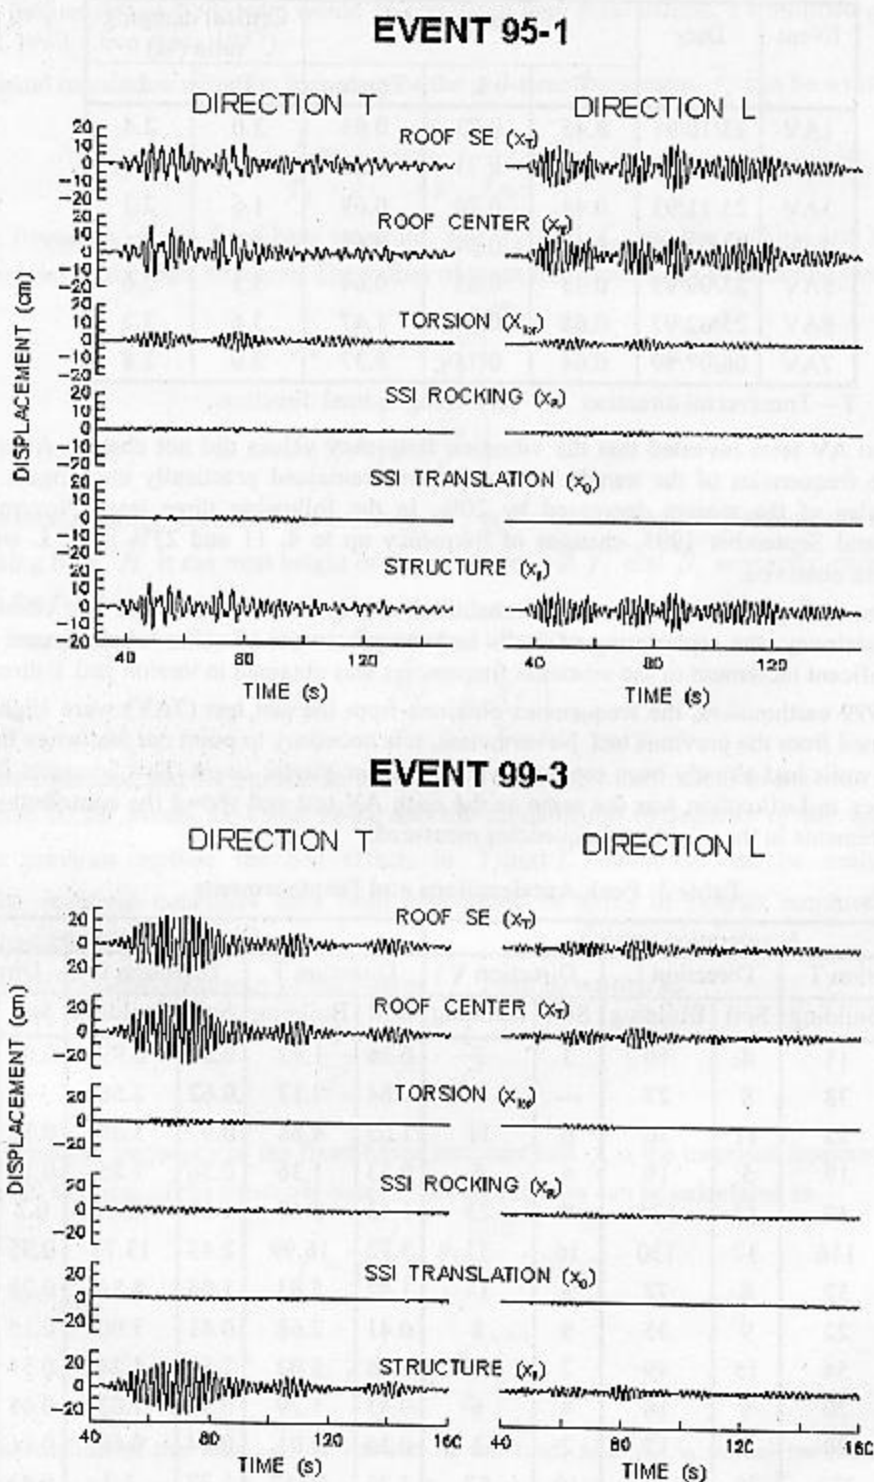
Fig. 10 Time-histories of displacements at roof level, with contributions of different sources deformation, calculated for events 95-1 and 99-3

Figure 10 shows the case of the 95-1 and 93-3 events. In this figure, time-histories of the total displacements ( $x_T$ ) at the centre and at one corner of the roof level in the T-direction are shown, along with the contributions to these displacements, due to rocking and translation at the base plus the torsion. The torsional motion ( $x_{tor}$ ) was derived from the differences between the horizontal movements at roof corners. The rocking motion ( $x_R$ ) was calculated by the product of building height and angle of base rotation, assuming that the base is rigid for out-of-plane bending. The angle was derived from the vertical motions recorded in the corners of the basement level. Base translation displacement ( $x_0$ ) was computed by subtracting that at the field site instrument (G) from that at the basement (BC). Finally, displacements due to the flexibility of the structure ( $x_F$ ) were obtained by subtracting from the motion at the roof (RC) those obtained from base rocking and translation.

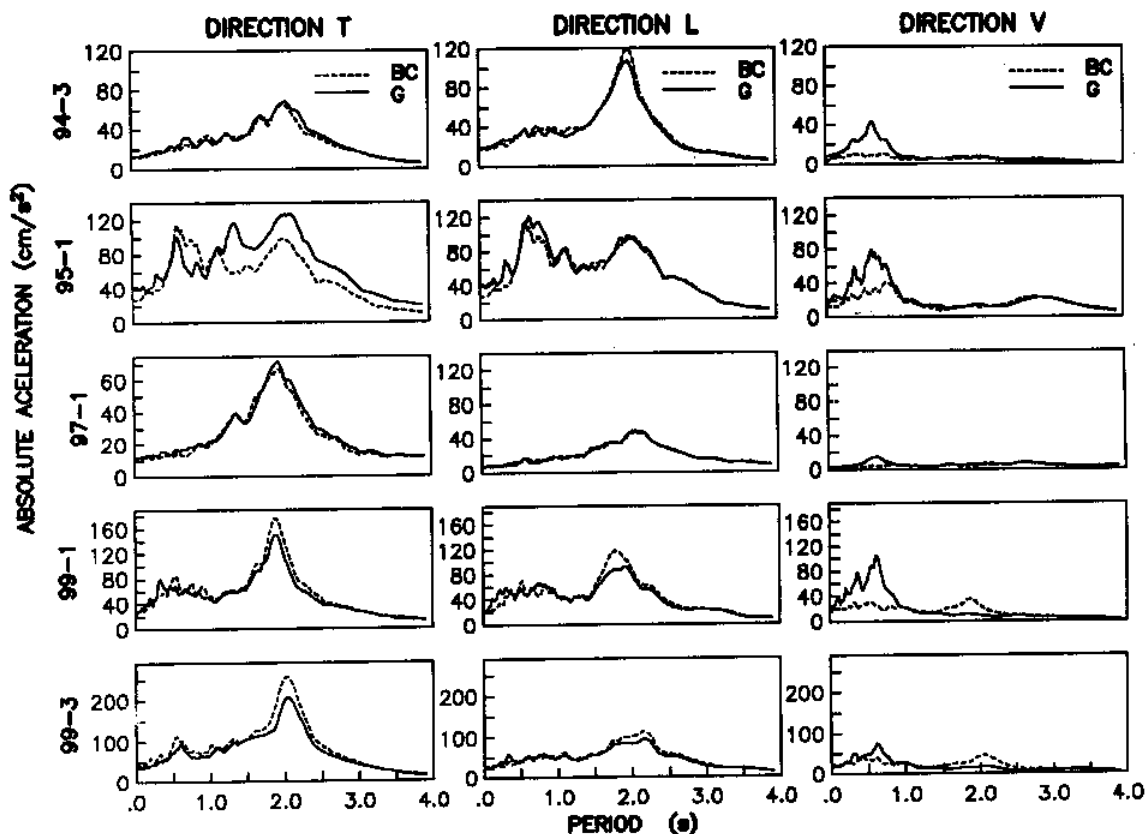
Fig. 11 Response spectra from the basement centre (BC) and from field site (G)

Response spectra, for 5% of critical damping, were calculated with the records of the field site and the centre of foundation in site BC. In Figure 11, for the greatest intensity events, the spectra of the three components (T, L and V) of these two measurement points are compared.

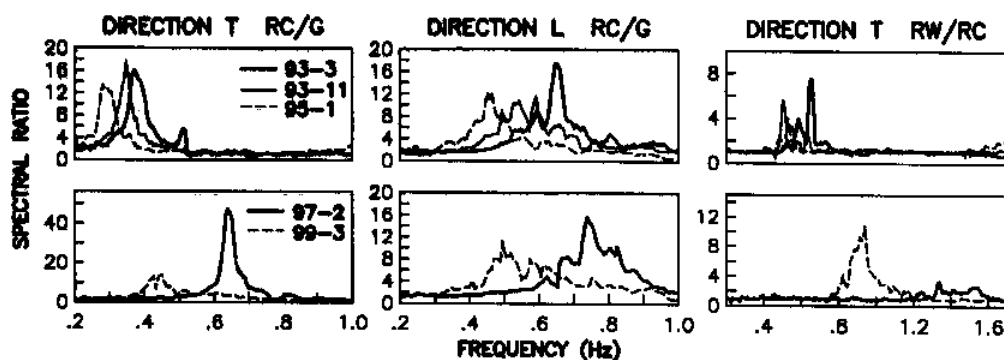
Fig. 12 Estimated transfer functions between the motions at roof centre and at field site (RC/G), and between the corner and the roof centre (RW/RC)

Figure 12 shows some estimated transfer functions obtained to illustrate the variations of the frequencies of three principal modes. The shapes of the curves and the intervals of maximum ordinates vary from one event to another. Furthermore, for some events, more than one significant peak appeared around a modal frequency. Therefore, the system exhibited non-linear behaviour even during seismic intensities considered as low or moderate.

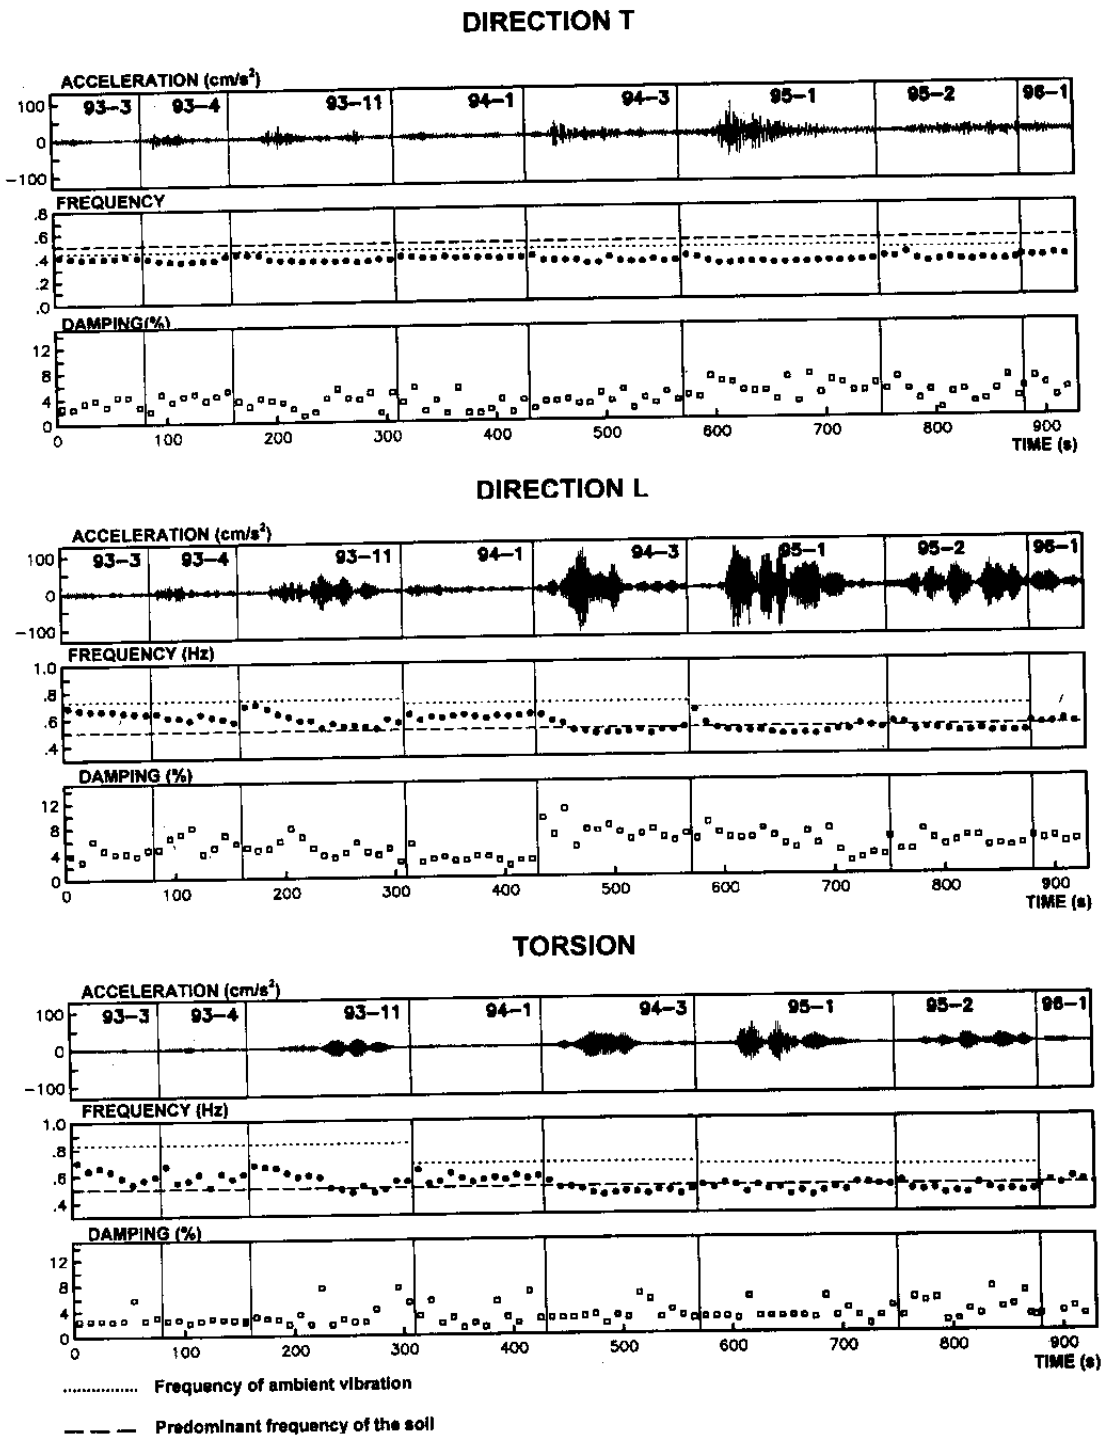
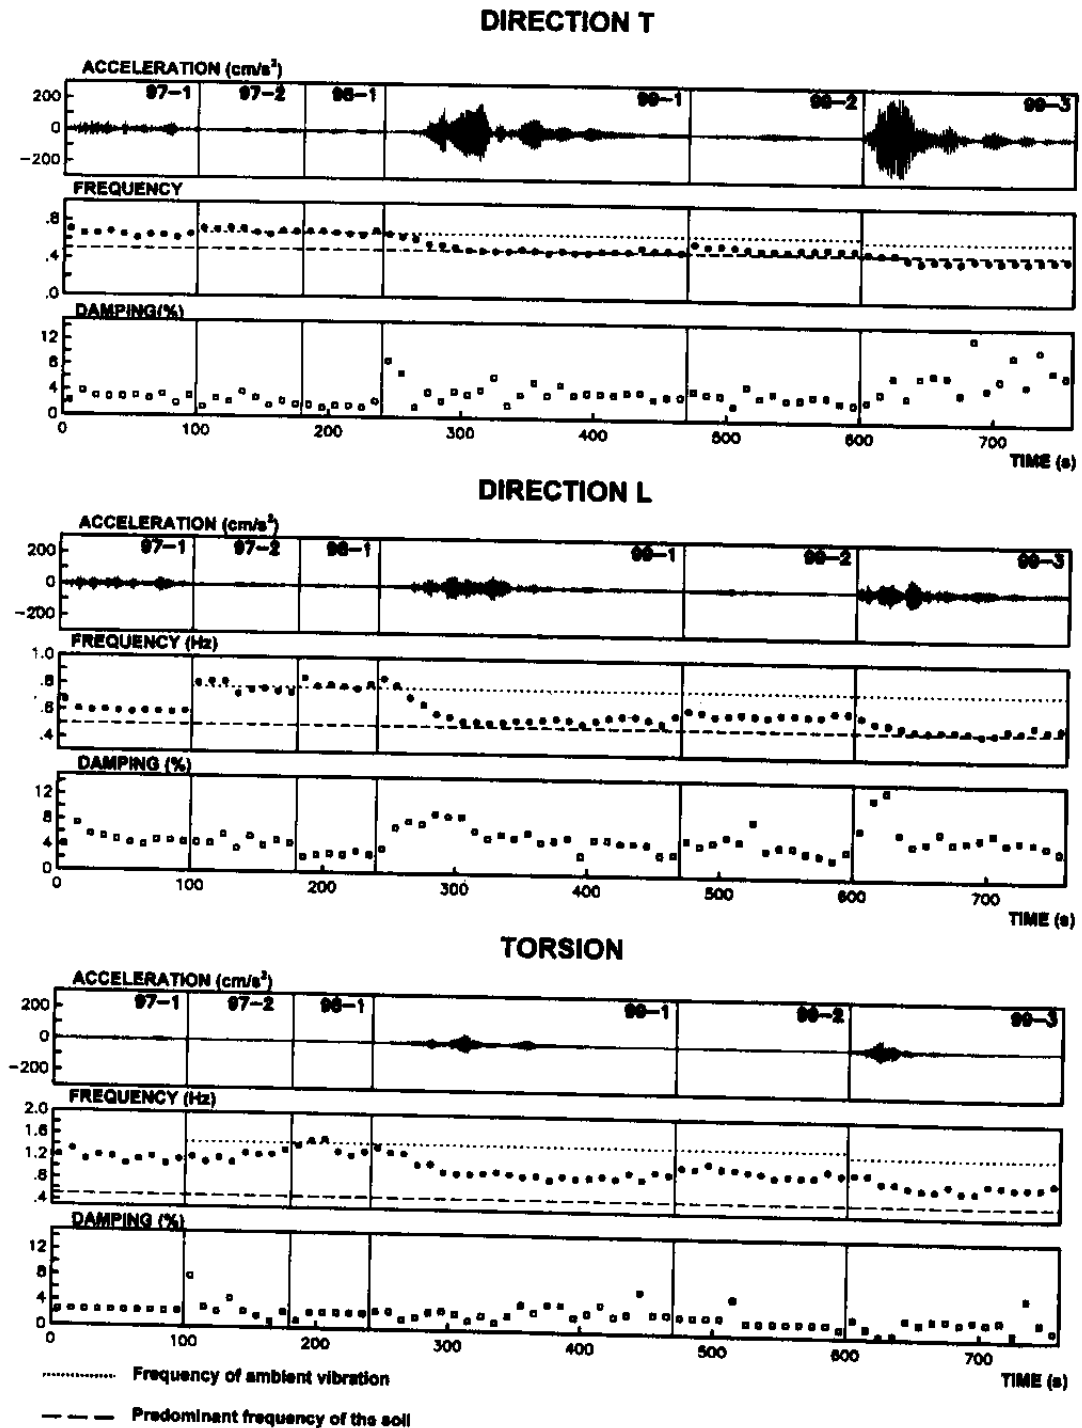
Fig. 13 Acceleration time-history recorded at RC site and time-variation of the dynamic properties of the events before the second rehabilitation

Figures 13 and 14 show accelerograms recorded at a point located on the roof. The first modal frequency (dot) and damping (rectangle) are plotted versus the time corresponding to the middle of each window. The horizontal line represents the AV frequencies and the predominant frequency of the soil. It can be seen that values along the duration of each earthquake have an amplitude-dependence on the input motion. In the intense phase of the event, the major reduction of frequencies occurred, and after this phase of the most significant events, a partial recovery of the values of the frequencies was observed.

The lowest values of frequencies of each event identified from the non-parametric (NPT) and parametric (PT) techniques are compared in Table 5. The estimated results are quite similar. After each rehabilitation of the building, a clear process of stiffness degradation of the system was observed. This fact is attributed to cumulative effects of several earthquake motions during the two periods of observation. The vibration frequency tends to decrease for increasing intensities of the motions or drift indexes, as is shown in Figure 15. In this figure, after the second rehabilitation, the influence of the braces in the T-direction frequency is evident.

Before the second rehabilitation, the maximum reductions in the fundamental frequency of lowest PT values between the first event (93-3) and the 95-2 event were 23, 30 and 22% in T, L and torsion, respectively. However, 5 to 11% of these reductions have been recovered at the end of the 95-2 event. When the second rehabilitation was completed, the reductions between events 97-2 and 99-3 were 35, 33 and 31%, respectively. In this observation period, 13 to 47% of reductions have been recovered at the end of the event 99-3.

These decreases of frequencies suggest apparent losses of stiffness of the system. If it is assumed that the masses have not changed, these losses can be considered from the variations of the fundamental frequencies between two events. In the first case, for those changes that occurred previous to the second rehabilitation, the smaller frequencies, estimated by using the analysis by windows, of the events 93-11 (not-visible damage), 94-3 (visible damage), 95-1 (high intensity record) and 95-2 (visible damage), were compared with respect to the first registered event (93-3). In the second case, for events that occurred after the second rehabilitation i.e. 99-1 (visible damage), 99-2 (not-additional damage) and 99-3 (high intensity record), results are compared with respect to the event 97-2. The results presented in Table 6 show large apparent losses of the stiffness. In the first case, the highest value corresponds to L-direction (51%) and in the second case, to the T-direction (58%).

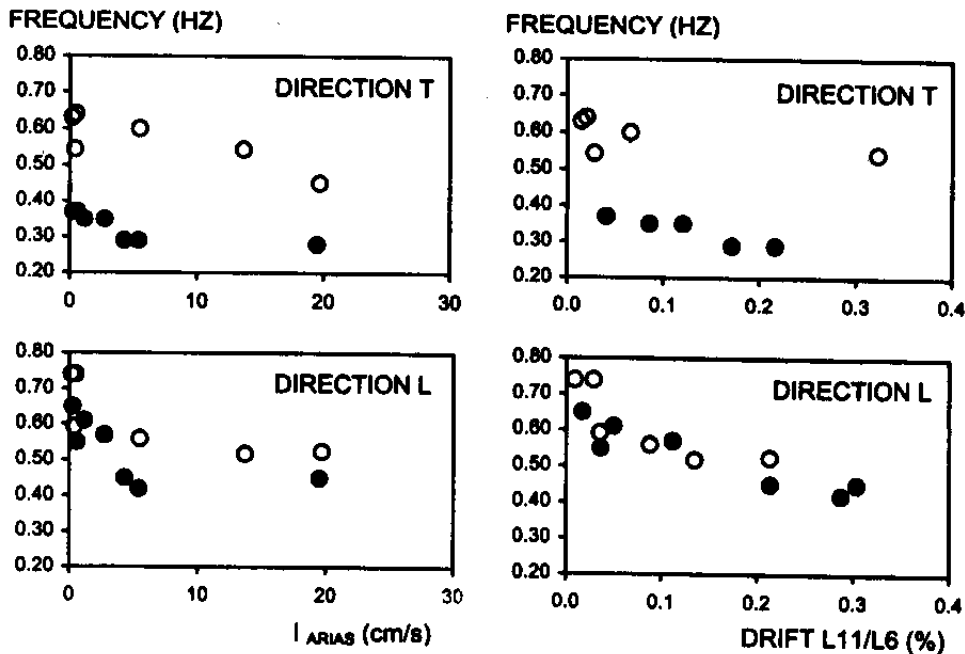
Fig. 15 Arias intensity ( $I_{Arias}$ ) and inter-story drift variation of soil-structure system frequencies (• before the second rehabilitation, ○ after the second rehabilitation)

The above-mentioned data shows great sensitivity of the SSI effects to the intensity of the input motion and to the changes in the structural characteristics following both deterioration and rehabilitation work. In order to analyse this behaviour for the four most intense events, the variations of the fundamental frequencies of the system and of the structure with the Fourier analysis of moving windows (Udwadia and Trifunac, 1974) have been estimated. The length of the time window is taken as 10 s. Figure 16 presents the frequencies  $\overline{f}_1$ ,  $f_1$  and  $f_R$  obtained from the moving window analysis during these events. The  $\overline{f}_1$  and  $f_1$  values show the amplitude-dependence. Furthermore, the relationship  $f_1/\overline{f}_1$  also shows the amplitude-dependence during an event; this is very clear for the event 99-1. The values of  $f_H$  (not given here) and  $f_R$  do not have a clear tendency, and their frequencies ranges are 0.90-3.70 Hz and 1.00-1.70 Hz, respectively.

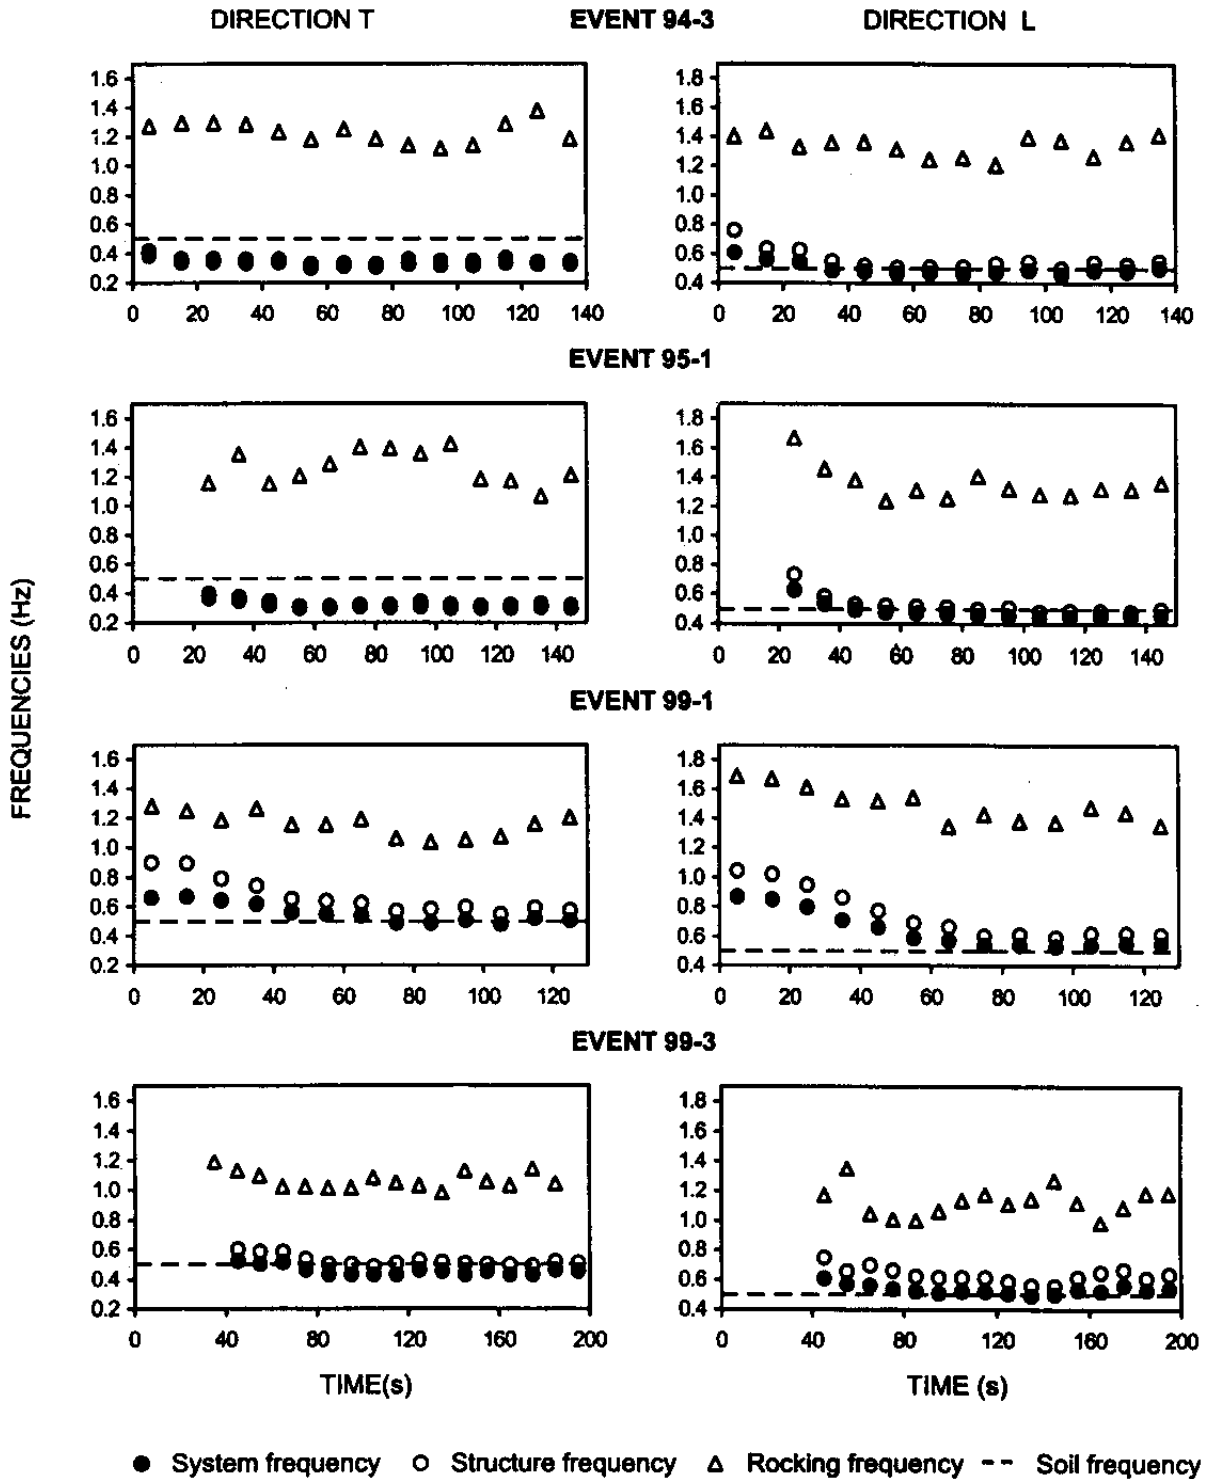
Fig. 16 Time variations of frequencies, before second rehabilitation (94-3 and 95-1 events) and after second rehabilitation (99-1 and 99-3 events)

With this adopted simplified procedure, the reductions of the frequencies of vibration of the system ( $\overline{\Delta f}_1$ ), of rocking ( $\Delta f_R$ ), of translation ( $\Delta f_H$ ), and of the structure ( $\Delta f_1$ ) during the most intense events with regard to the first registered event can be analysed approximately (Table 9). When comparing the reductions of  $\overline{\Delta f}_1$  and  $\Delta f_1$ , it is observed that those are similar. This indicates that the variations of the

frequencies of rocking and translation have a little influence on the variation of the frequency of the system; this suggests that it is feasible to estimate the losses of stiffness from the variations of the frequencies of the system. This also holds for the variations in the frequencies of torsion of the system ( $\Delta f_{tr}$ ) and of the structure ( $\Delta f_{st}$ ).
