PRELIMINARY REPORT ON JANUARY 19, 1975 KINNAUR EARTHQUAKE IN HIMACHAL PRADESH

INTRODUCTION

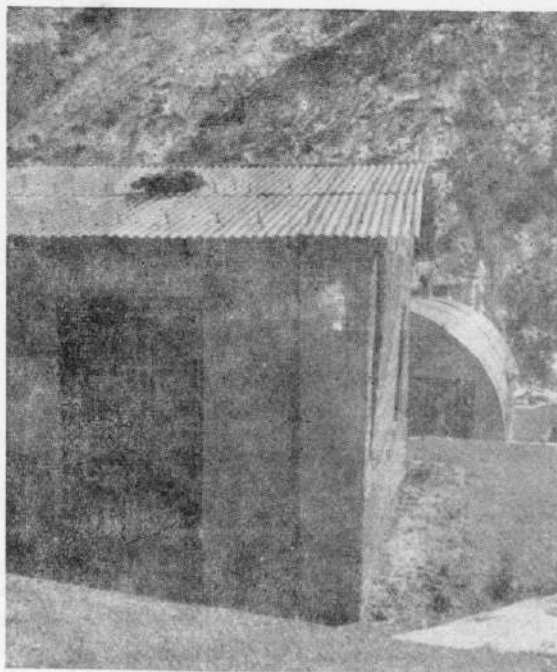
Some recent constructions near Sumdoh village on the terrace on right bank of Parachu river were constructed in hollow concrete blocks. Fig. 11 shows the collapse of the gable end wall of a hall whereas the columns and corrugated iron sheet roof resting on steel trusses did not suffer any damage. Fig. 12 shows tilting of the filler wall in such construction. Fig. 13 shows cylindrical shed made of corrugated iron sheets nailed on timber arches. The end wall made in timber frame with concrete blocks as filler walls did not suffer significant damage, except cracks along mortar joints. Some of the E-W walls collapsed completely.

Fig. 12. Tilting of filler walls made of hollow concrete blocks near Sumdoh village.

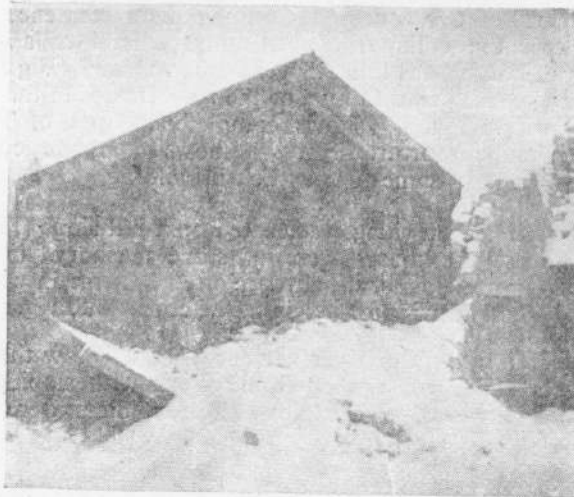
Fig. 27. Collapse of gable end wall in dispensary at Chango village. Collapse of interior walls and fall of plaster is also seen.

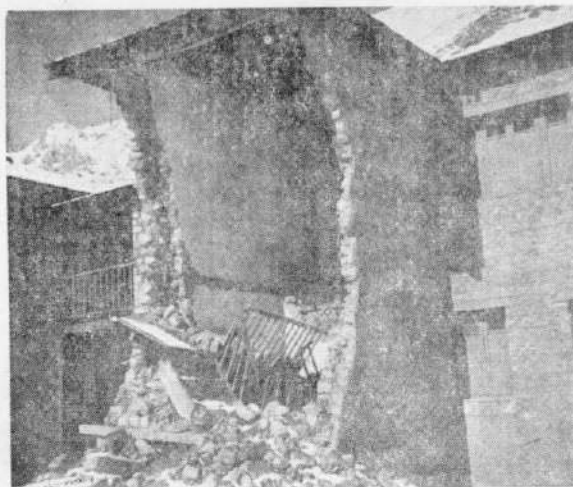
Fig. 33. Collapse of staircase well on the rear of the police station building at Leo village.

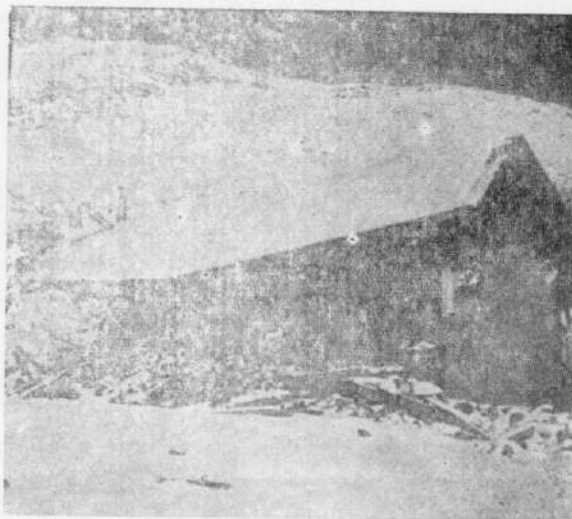
Fig. 38. Collapsed "patwari" and "kanungo" house at Leo village.

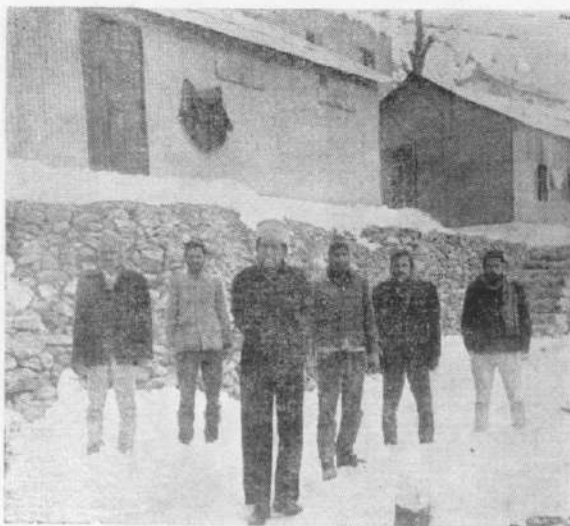
Recent construction on the river terrace 250 m. below the village made up of corrugated iron sheets nailed on timber frame work with sloping roofs did not suffer any damage (Fig. 44). However, cracks along mortar joints were developed in stone masonry buildings.

Fig. 44. Undamaged houses made up of corrugated iron sheets nailed on Timber frame work with sloping roof at Pooh village.

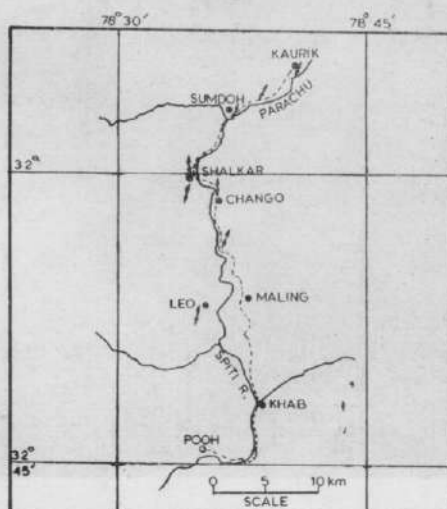
Figure 62 shows the general trend of the ground fissures as described above. These trends are in general parallel and subparallel to Kaurik-Chango fault shown in Figure 2.

Fig. 62. General trend of ground fissures in the epicentral tract of January 19, 1975 Kinnaur Earthquake

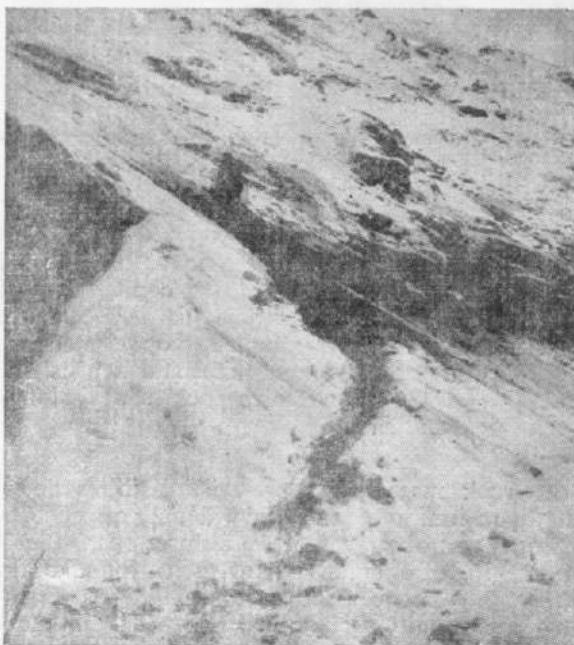
Figure 66 shows rock slide in quartzites on a hill side between Chango and Shalkar. Telegraph poles were tilted and jumping of insulators was responsible for falling of the telegraph wires and breakdown of the communication lines. Figure 67 shows landslide mass in thinly foliated phyllitic schists which entombed three ponies and a cow moving on the road (which was completely obliterated by the slide). Fig. 69 shows debris from rock falls in interbedded quartzites and schists in hill road between Mallang and Chango. Fig. 68 shows extensive rock slides along a road near Kah in granite gneisses between Pooh and Mallang.

Fig. 67. Landslide in thinly foliated phyllitic schist on H.T. road between Chango and Shalkar.

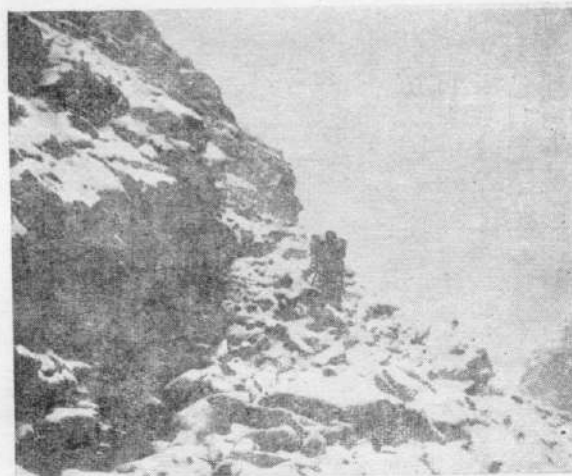
Fig. 69. Debris from a rockfall in interbedded quartzites and schists between Malling and Chango.

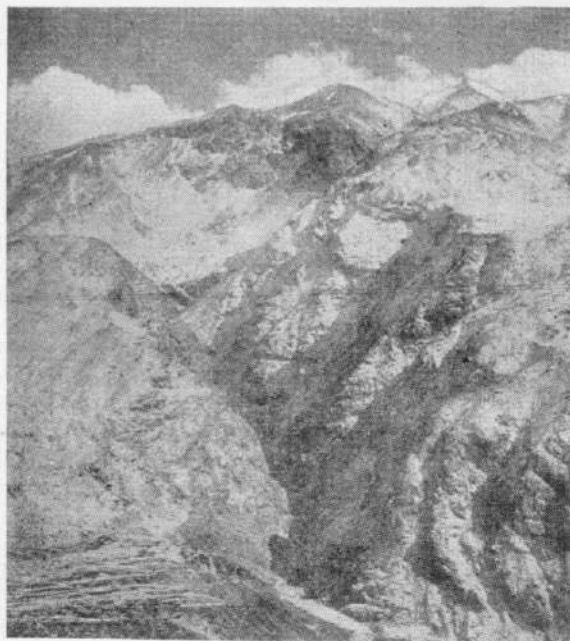
Fig. 78. A view of Parachu gorge near Kaurik village.

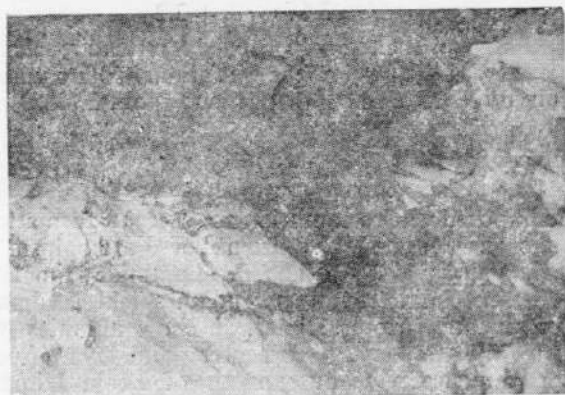
Loosening of the rocks along joints and other pre-existing discontinuity surfaces and movements along them have resulted in changing the seepage outlets in some of the surface springs in the area. Figure 79 shows the outlet of a natural spring in limestones near Shalkar village. This spring ceased to flow due to readjustment in the limestone along joints. However, this spring has emerged due to opening of joints at a lower

Fig. 79. Stoppage of flow of water in a natural spring in limestones near Shalkar village.

elevation in the same area after the earthquake. Landslide debris was also reported to have buried many other surface springs in the region.
