## EARTHQUAKE IN SOUTH INDIA ON 20th MARCH 1984

R. NARAYANA IYENGAR<sup>1</sup> AND K. MEERA<sup>2</sup>

### ABSTRACT

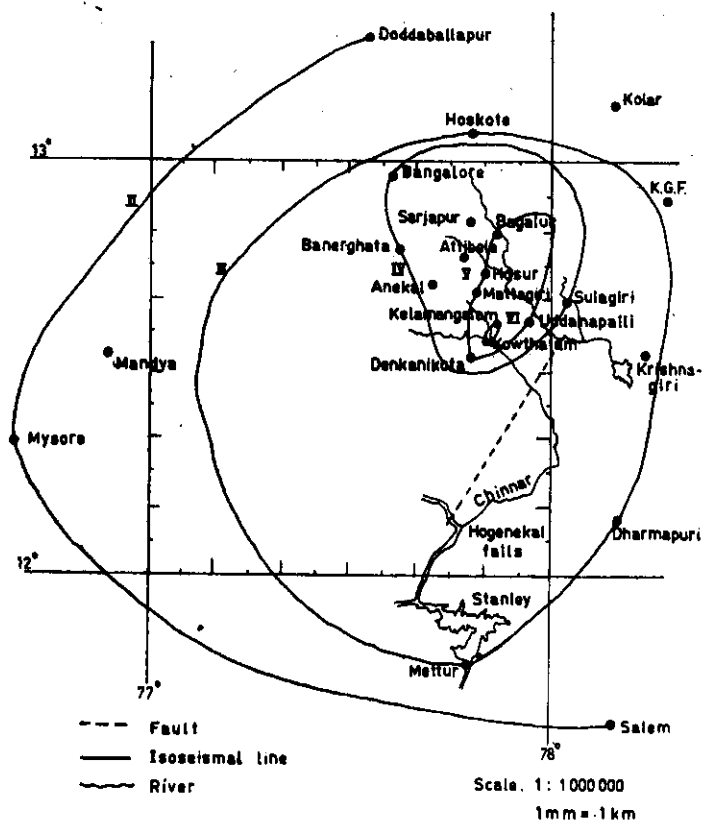
Fig. 1. Isoseismal map of the South Indian earthquake of 20-3-1984.

A description of the seismic disturbance in various places enclosed by isoseismals IV, V and VI is given below. The classification of buildings as type A, B, C follows the IS Code 1893-1975. The isoseismal map is presented in Fig. 1.
