DAMAGES DURING DHAMAR EARTHQUAKE OF DECEMBER 13, 1982 IN YEMEN ARAB REPUBLIC

A.S. ARYA, L.S. SRIVASTAVA AND SATYENDRA P. GUPTA*

SYNOPSIS

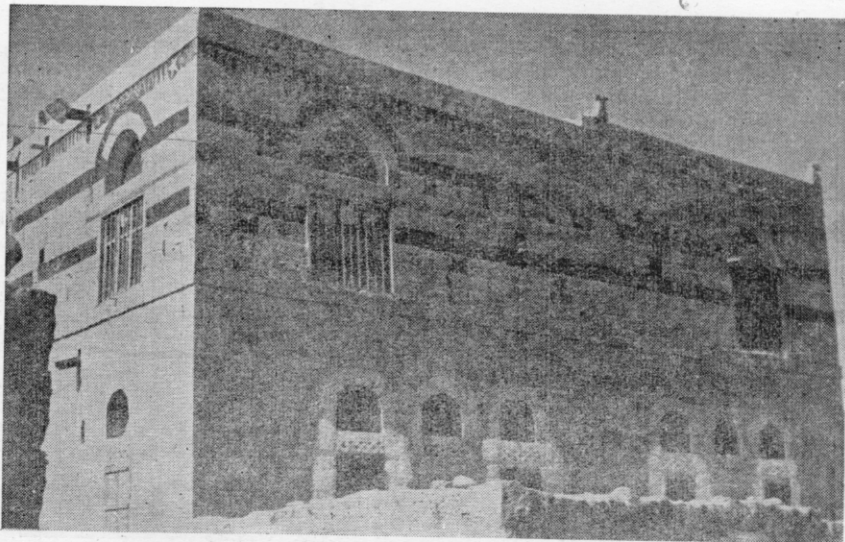
Photo 20. Dressed stone two storied house in village Dhi-Hawlan, use of wood piece at corner of walls and over window. Apparently no damage.

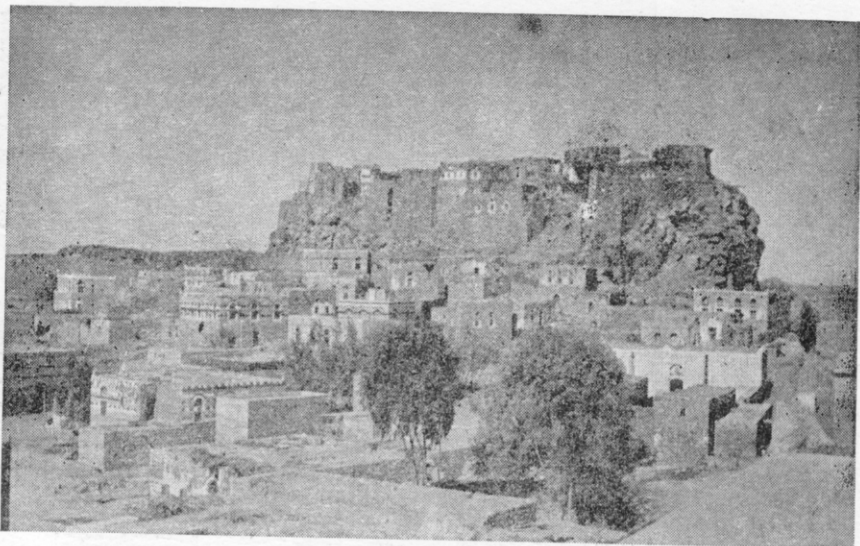
(b) *Foundation of Stone Masonry Walls*—Most old buildings are built on cliffs as shown in photo 21 and hill sides (photo 24) resting on exposed rock directly. Where they rest on soil, foundations are dug to shallow depths and packed with stones with or without mud.

(e) *Roof and Intermediate Floors*—In almost all houses using stone masonry or adobe construction for walls, the roofs are flat type (photo 21). The traditional roof has wooden rounds, half rounds or roughly dressed joists or proper rectangular joists placed parallel to each other across spans of 3 to 3.5 m at a centre to centre spacing of about 45 cm. This limits the width of the rooms which may, however, be made to have long lengths, even as much as 12–15 m. Across the wooden beams and over them are laid thin wooden planks or bushes or weeds to form the deck for receiving clay topping. The clay topping thickness may vary from 15 cm to 25 cm. When used as floor, a concrete screed with plaster on top is some times used. The roof requires

Photo 21. General view of random and coursed stone and adobe construction with houses on hill top at village Dhi-Hawlan.

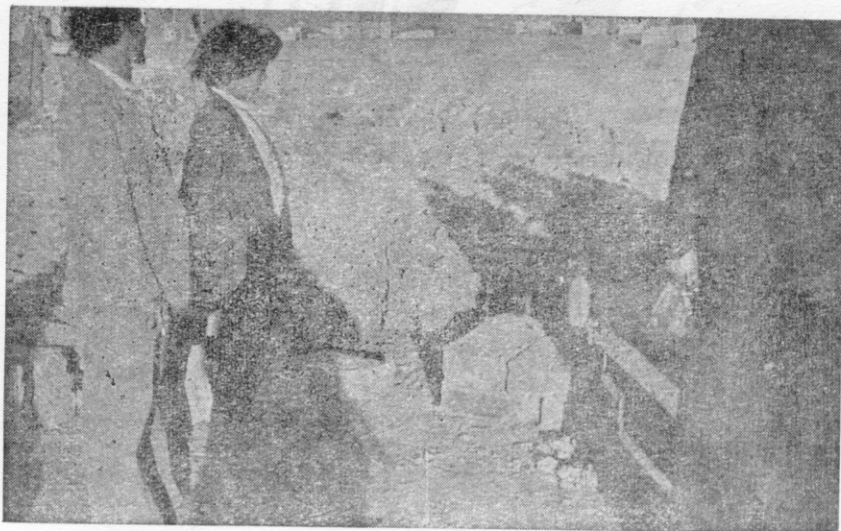
(d) *Adobe Block Walls*—In adobe construction also there is usually no foundation provided and the wall making starts right from the ground level. Generally 37 cm \times 25 cm \times 11 cm size blocks of adobe (photo 25 and 26) are used which permit use of a good bond breaking the vertical joints. Site test indicated that this adobe can bear the weight of a person weighing about 75 kg on a clear span 25 cm, hence having good enough tensile and compressive strength. Three storied houses were seen to have been constructed using this type of adobe.

Photo 25. Adobe making in progress in village Al-Olayb. Corner wall construction shown size of adobe is such that breaking of vertical joints in different courses is perfectly arranged.

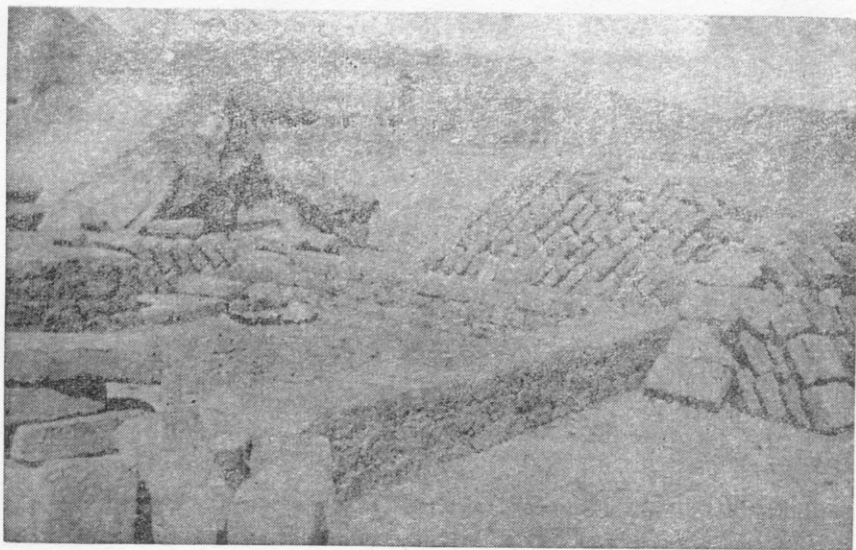
Photo 26. Adobe construction in progress in village Wasta.

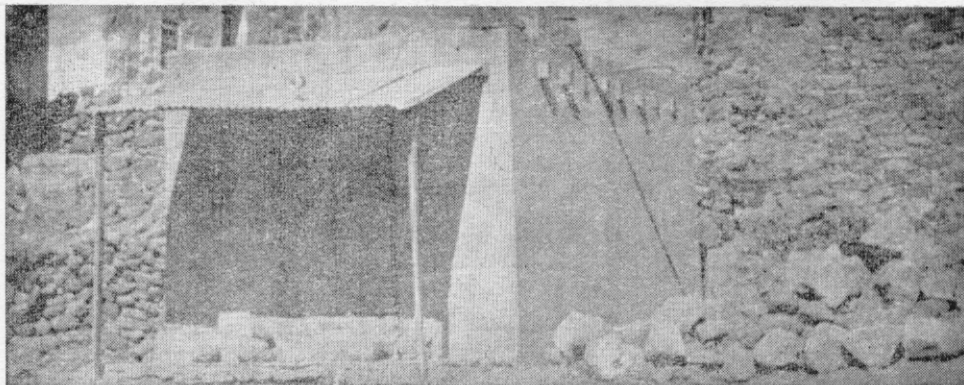
Photo 32. A single storied (apparently newly built) ration shop located at the foot of the hill was not damaged in village Dohran. See cement plaster outside the walls.

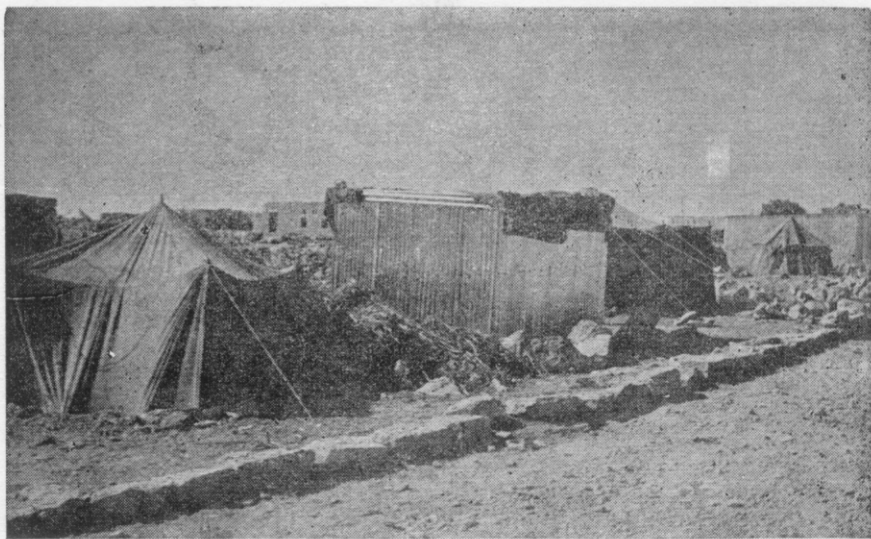
Photo 40. Tents and Tin sheds provided to the people as a relief measure at Village Hizrat Mangada.
