## REPAIR AND STRENGTHENING OF EARTHQUAKE DAMAGED HOUSES IN MAHARASHTRA

Central Building Research Institute, Roorkee (U.P.)

### ABSTRACT

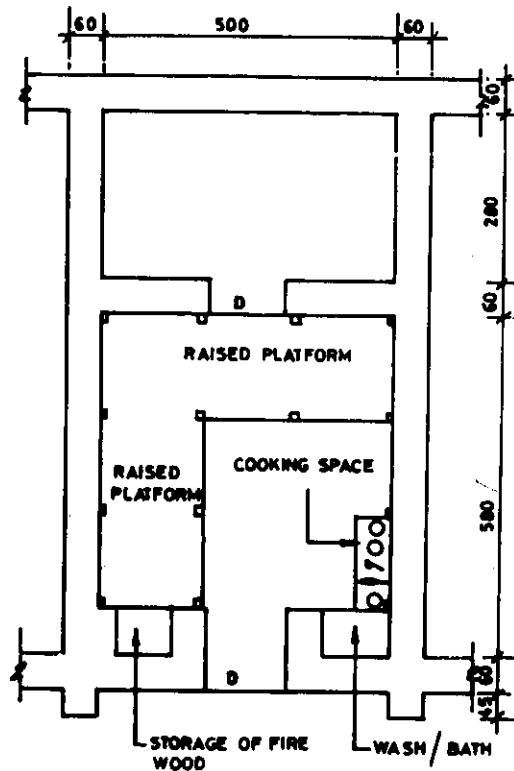
Fig.1 TYPICAL PLAN OF A HOUSE IN LATUR DISTRICT

A typical plan of a common house with two rooms is shown in Fig.1. The plinth of the house is about 45cm high. The entrance and right side of the front room are at plinth level, while the rest of the area of the house was raised to a height of about 90cm above plinth. An incremental concept of housing had been adopted, with addition of rooms in stages, as per owner's requirement.
