THE GREAT HANSHIN MARTHQUAKE OF JANUARY 17,1995

G.R.Reddy, H.S.Kushwaha, S.C.Mahajan Reactor Engineering Division Bhabha Atomic Research Center Bombay-400085, India

Kohei Suzuki Professor, Department of Mechanical Engineering Tokyo Metropolitan University Tokyo 192-03, Japan

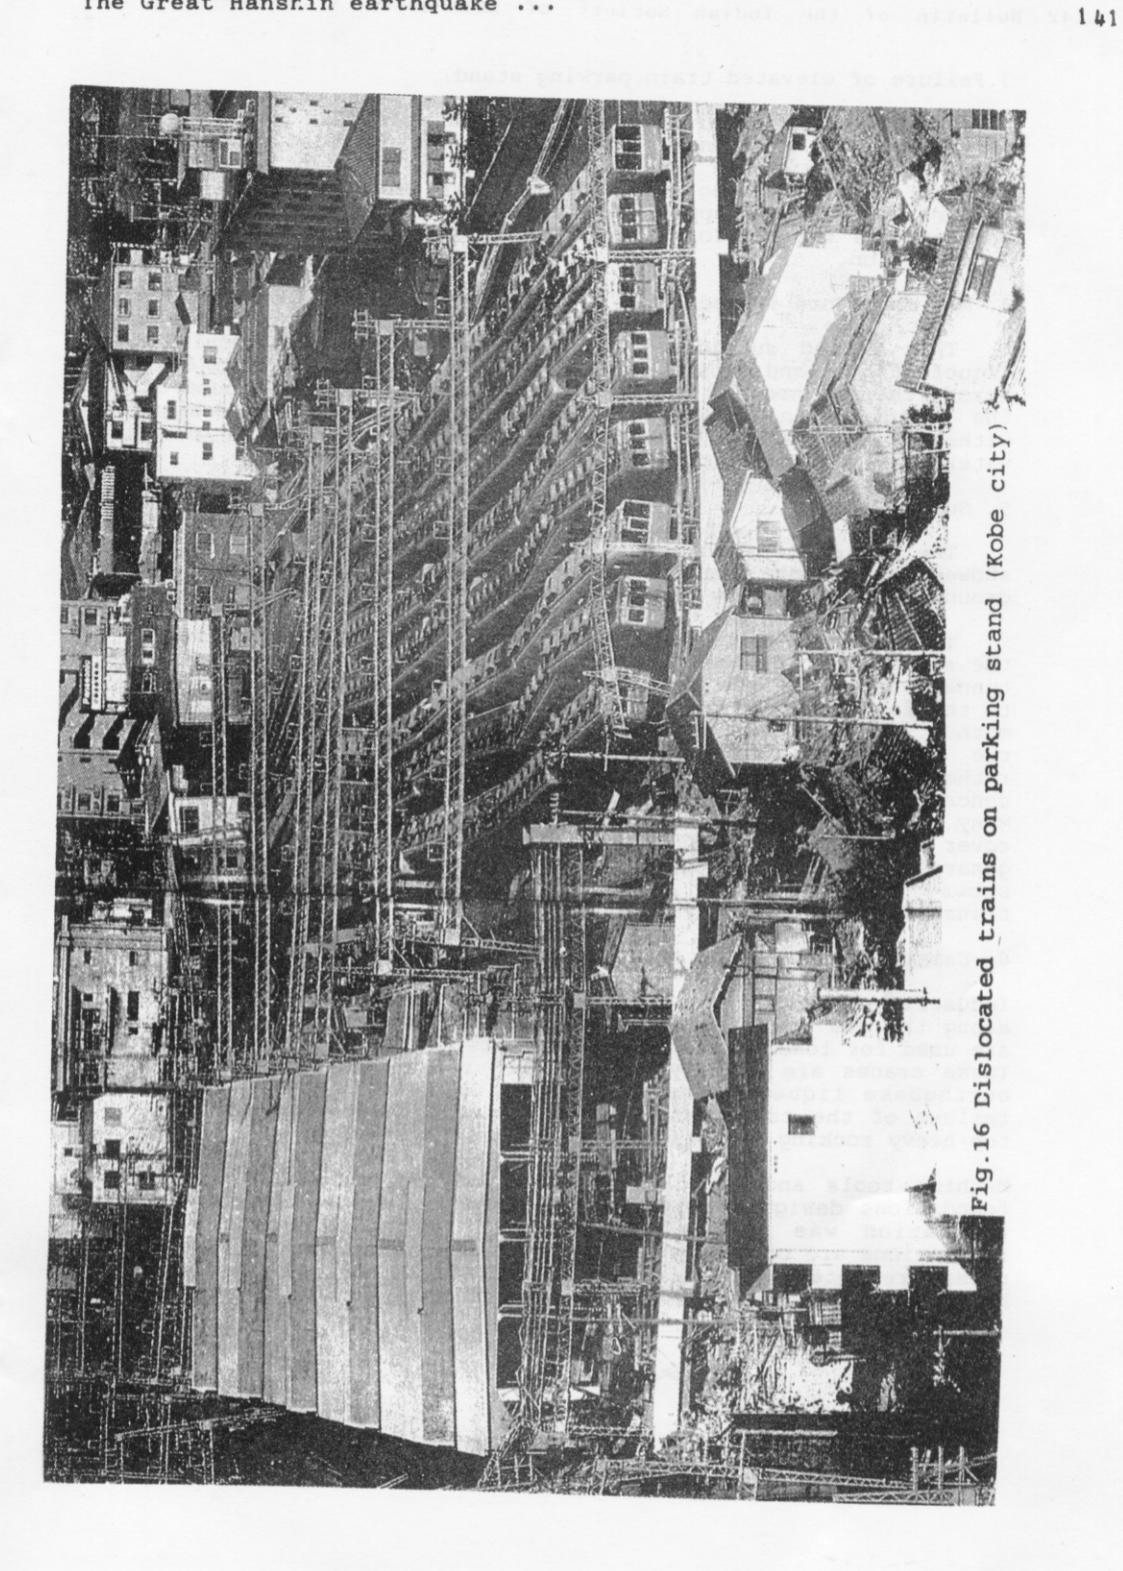
To save space, train parking area was provided on elevated platforms. The area under the platform was provided for shops. Dislocated trains in the parking area are shown in Fig.16. Failure of the parking stand columns are shown in Fig.17. The reasons for failure appear to be a strong floor weak column, asymmetry of the platform and uneven settlement of columns due to liquefaction.
