## **SEISMIC RESPONSE OF A TWICE-RETROFITTED BUILDING**

David Murià-Vila, Gerardo Rodríguez, Arabella Zapata and Ana María Toro

### **ABSTRACT**

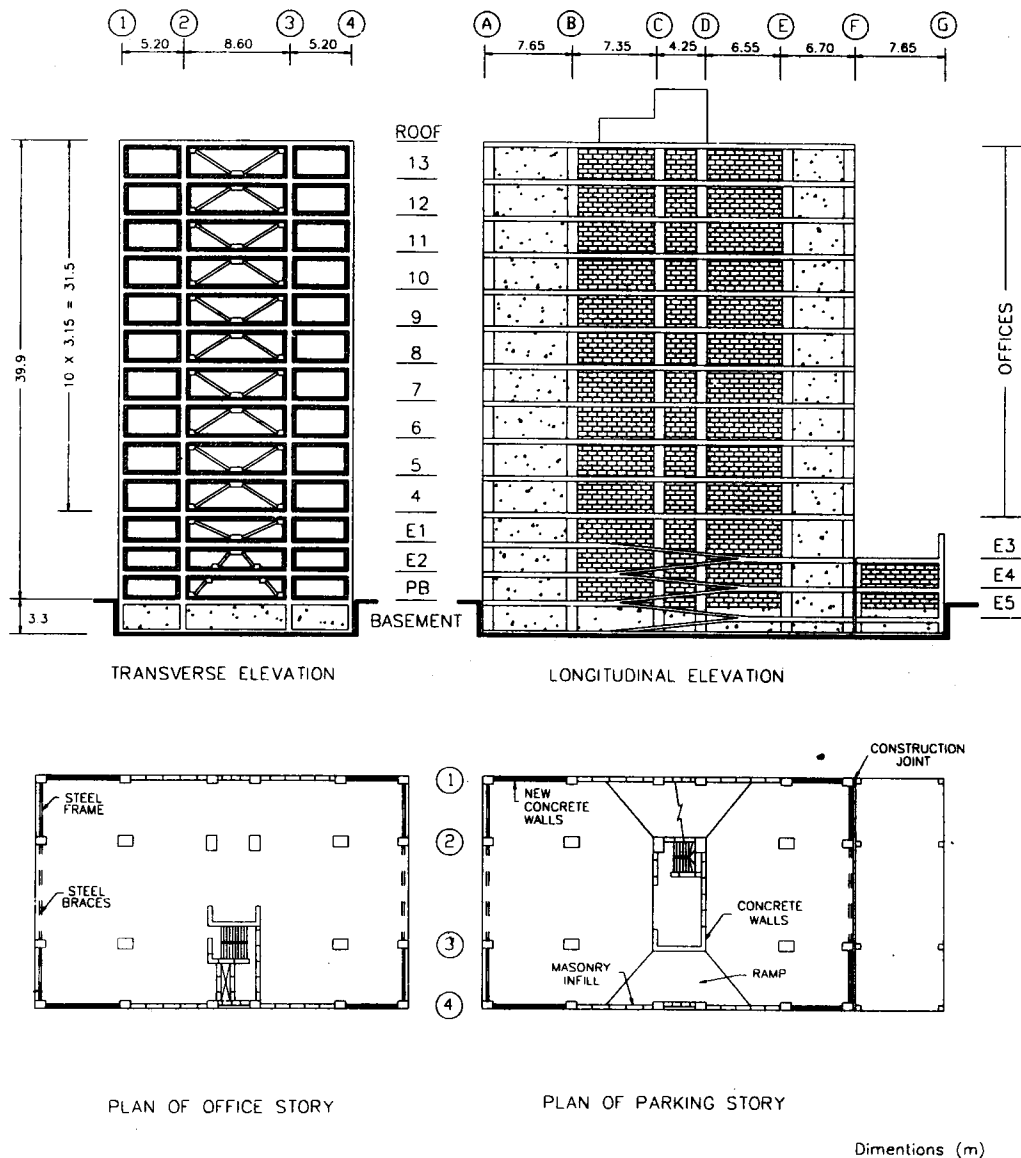
Fig. 1 Elevation and plans of building

Since it is located in the Mexico City area where the greatest damage was observed during the 1985 earthquake, and because large vibrations are expected due to its flexibility, the Jal building was selected among 50 candidates for study. This was built in 1981 using the Mexico's Federal District Constructions Code (RCDF, 1976). It is a 14-storey reinforced concrete structure occupied by offices, except for the first four stories, which are used for parking. The building has a small three-level adjoining structure, separated by 150 mm from the main structure and attached at the base. Originally the structure consisted of a waffle flat-plate (450 mm thick) on rectangular columns with a box-type masonry wall around the staircases, a small core of concrete shear walls around the elevator shaft, and masonry infill walls in the end frames of the longitudinal direction (L). The detailing of the reinforcement does not comply with present requirements for ductile structures, especially regarding the transverse reinforcement in columns and in slab-column joints. Figure 1 shows a schematic view of the structure.

The building was then strengthened in 1986 by adding infill concrete walls in the L direction connected to the original structure only through the upper slab. The sections of the interior columns were jacketed with new reinforced concrete without any modification to the foundation (Figure 1). The masonry walls were merely covered with plaster, and the cracks of the slabs were not repaired.

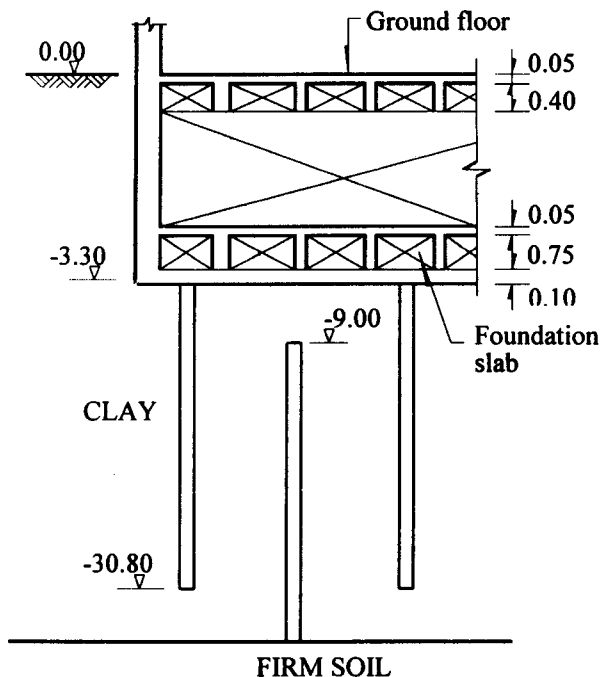
Fig. 2 Vertical cross-section of the building foundation

The foundation consists of a concrete slab on friction piles, driven according to a rather peculiar solution, as shown in Figure 2. The so called A-piles are fixed to the foundation slab and driven into the clay soil without reaching the firm layers. B-piles are driven down to the firm layer but are separated from the foundation. The weight of the building is assumed to be supported by the lateral friction of the piles and partially transferred from the A-piles to the B-piles, thus avoiding a foundation failure while at the same time allowing the building to sink following the areal settlement of the ground.

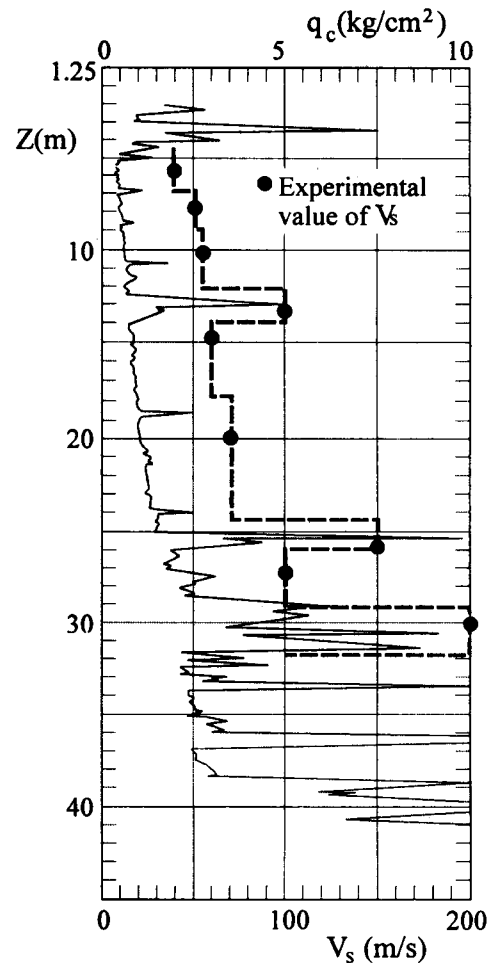
Fig. 3 Shear wave velocity ( $V_s$ ) profile and cone penetration resistance ( $q_c$ ) at the building site

front of it, where a field (surface) station was placed. Also, at the field site, a selective sampling and seismic cone testing (SCT) was executed. Figure 3 shows the soil profiles at the building site. In general terms, under a crust of about 5 m, the upper soft clay deposits extend to a depth of 29.5 m, followed by a 3 m thick intermediate firm layer. The lower clay layer extends from 32.5 to 38.5 m depth, followed by the so-called deep firm deposits. The shear wave velocity profile, determined from the SCT tests, is also shown in this figure.
