## RESPONSE OF STRUCTURES IN BROACH EARTHQUAKE †

B.S. Bulsari\* and M.C. Thakkar\*

† Presented at the Fourth Symposium on Earthquake Engineering, Koorkee, November 1970.

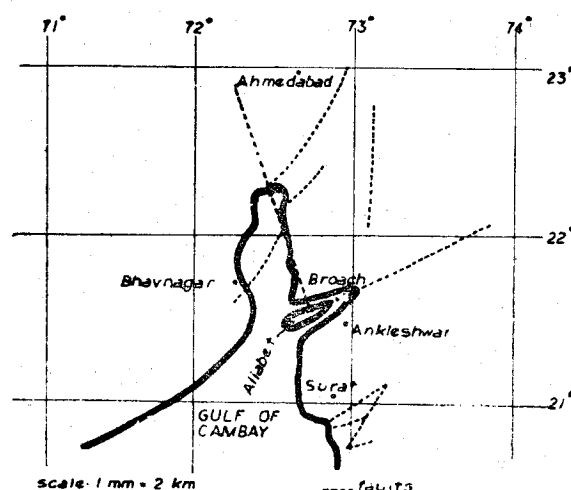
Fig. 2. Network of faults in Broach district and nearby area.

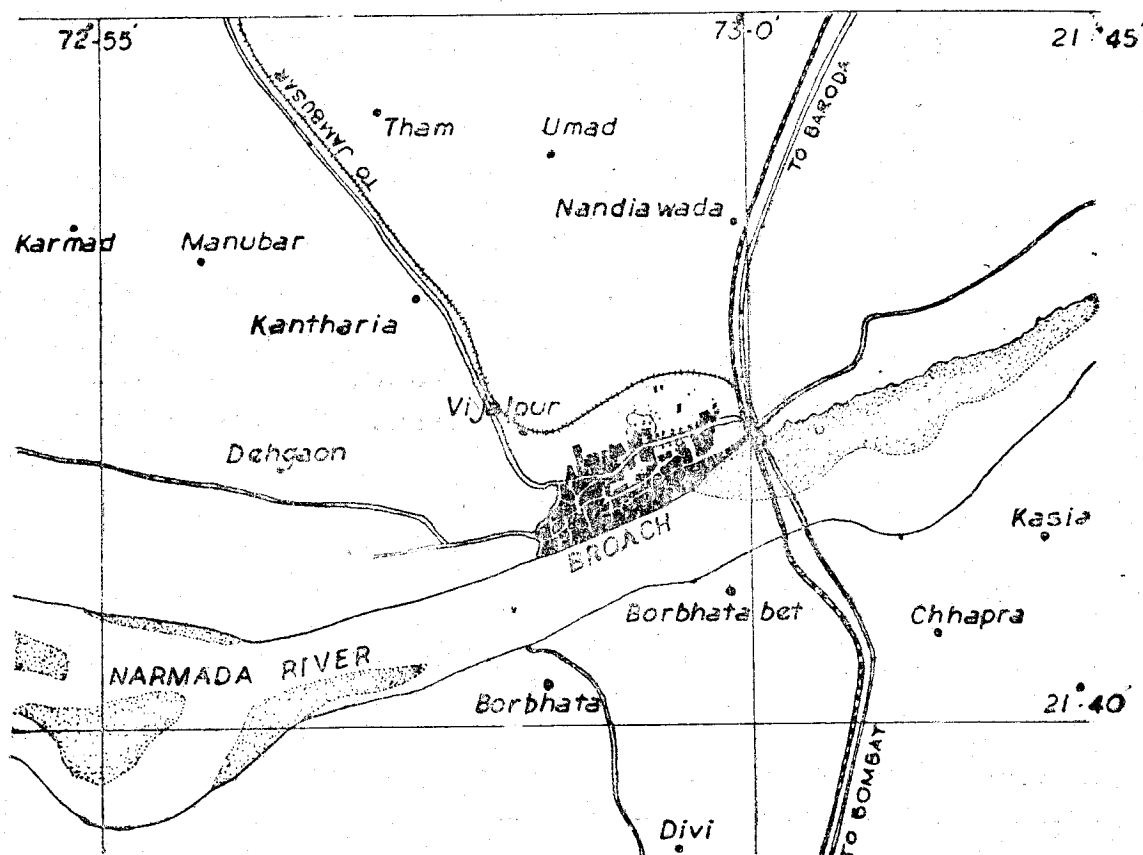
The major component of earthquake acceleration is N-S. This is very clear from the diagonal cracks on N-S walls. These cracks on larger panels are running from top at north to bottom at south, indicating the seismic force from north to south (Fig. 3). This direction is also very clear from fallouts of E-W walls. The photograph (Fig. 4) shows the shift of bench seat to south from the seat rests. Cracks produced by the earthquake at the surface of the ground at Kasia and Borbhata are approximately E-W, clearly indicating the N-S direction of seismic force (Fig. 5)

Figure 5. Map of Broach District.

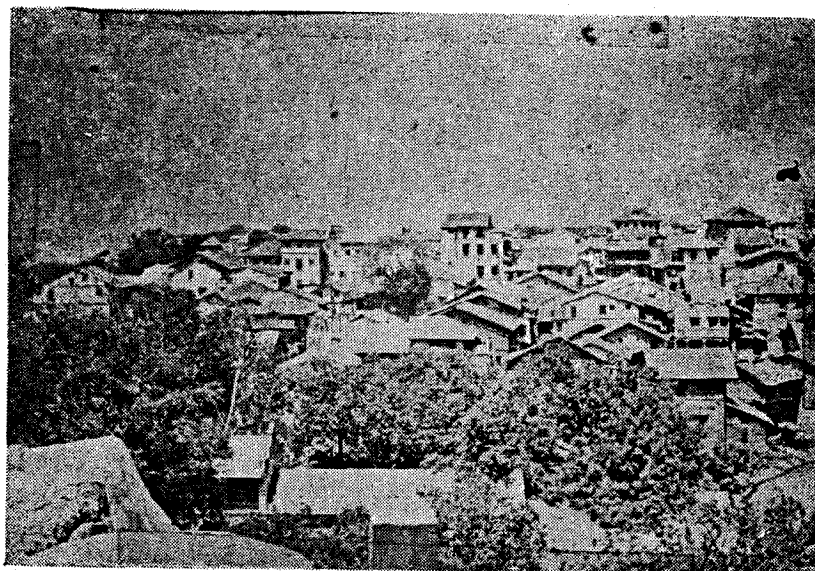
Broach developed on the northern bank of the river Narmada, due to abundance of water and good fertile land, which were the principal factors for habitation in pre-historic periods. Due to proximity of sea, Broach was once a good port, the fact which contributed to the development of the town. However, with the coming up of Bombay as an international port and the technology of ship building evolving larger and larger vessels, the Broach port suffered a set back. Now the main revenue of the town and district is only on the cultivation of fields for cotton and tobacco. The possibility of industrialisation is also rare as the town is flanked by Surat on one side and Baroda on the other, where industrial estates are fast developing ; while Ankleshwar the nearby town is coming up rapidly due to oil and gas fields. The only importance of Broach town is that it is the governmental headquarters of the district. It is fairly covered by jungles yielding good timber. Broach is, therefore, principally a town covered by the residential structures of the type prevalent before reinforced concrete structures were adopted, with a very few RCC structures built recently. The photograph, Fig. 1, gives the general idea of the residential structures in the town.

Fig. 1. Structures in Broach
