DAMAGE TO RESIDENTIAL AREAS CAUSED BY LIQUEFACTION-INDUCED LATERAL FLOW DURING THE 2024 NOTO PENINSULA EARTHQUAKE AND SELECTION OF APPROPRIATE COUNTERMEASURES

S. Yasuda*

ABSTRACT

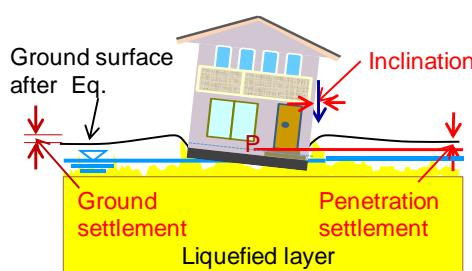
Fig. 15 Schematic diagram of a settled and tilted house

On flat land with a liquefied layer of uniform thickness, uniform subsidence occurred due to the change in volume of the liquefied layer and houses penetrated into the ground at some inclination due to the loss of bearing capacity or due to a decrease in the shear modulus of the liquefied layer, as shown in Figures 14 and 15. Two months after the Tohoku Earthquake, the Japanese Cabinet announced a new standard for the evaluation of damage to houses based on two factors, settlement and inclination. Houses tilted at angles of more than 50/1,000, of 50/1,000 to 16.7/1,000, and of 16.7/1,000 to 10/1,000 were judged to be totally collapsed, large-scale half collapsed and half collapsed houses, respectively, under the new standard, because in the steeply tilted houses, inhabitants felt giddy and nausea and could not live in their houses after the earthquake, though the walls, pillars and windows of the houses had no damage.

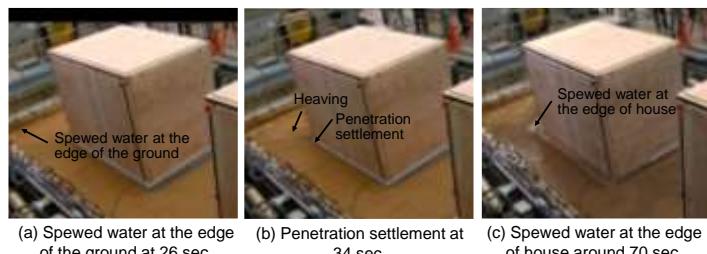
Fig. 16 Photographs of penetration settlement, heaving, and spewed water

The author and his colleagues conducted model tests using a large shaking table and a soil container owned by the Building Research Institute in Japan to demonstrate the mechanism of the penetration settlement of houses due to liquefaction Kaneko and Yasuda (2014). Figures 16 (a), 16 (b) and 16 (c) show the behavior of the model house and surrounding ground at 26, 34 and about 70 seconds, respectively. As shown in Figure 16 (a), water started spewing out of the ground at 26 seconds at the edge of the model ground. However, water did not spew out of the ground until the end of shaking around the model house, but spewed out several seconds after the end of shaking, as shown in Figure 16 (c). On the contrary, the penetration settlement accelerated at about 15 seconds, and, at 34 seconds, reached about 8 cm, which is about 80% of the settlement at the end of shaking. Figure 17 summarizes the timing of the occurrence of liquefaction (A), penetration settlement accelerated (B), water spewing out at the edge of the ground (C), the end of shaking (D), and water spewing out at the edge of the house (E), with the time histories of the ground and penetration settlements. As shown in this sequence, penetration settlement occurred first, then ground water spewed out around the model house. The ground surface settled gradually after the occurrence of liquefaction. Based on the model tests, the author concluded that a structure such as a building or a house did not sink into a hole that was produced by water spewing out, but penetrated into the ground due to a decrease in the shear modulus of the surface layer following the outside lateral flow of the ground under the house and the heaving of ground surrounding the house, as schematically shown in Figure 18. The ground surface settled slowly because the liquefied layer under and around the house densified gradually due the spewing out of the pore water.

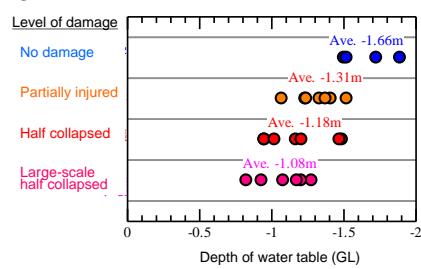
Fig. 21 Measured depth of water table at sites of damaged and undamaged houses in Urayasu (Yasuda et al., 2020)

The author and his colleagues measured the exact depth of the water table at the sites of about 28 damaged houses of Urayasu City. The measured depths are classified by the level of damage to wooden houses and plotted in Figure 21. As shown in this Figure, a water table of about 1.7 to 2.0 m below the ground surface was the critical depth to cause damage to houses. So, the author assume that the upper non-liquefied layer affects the damage to wooden houses as follows. When a liquefied layer is of uniform thickness and the upper non-liquefied layer is thin, houses penetrate into the ground, often at an angle, due to the lateral flow of the liquefied layer. In addition, uniform subsidence occurs due to the densification of the liquefied layer. However, if the non-liquefied layer is thick, penetration settlement and tilting is limited, though uniform subsidence due to the densification of the liquefied layer occurs. For the non-liquefied layer, it must be noted that the water table is not stable but increases during shaking for two reasons: i) the inflow of water from the lower liquefied layer due to liquefaction-induced densification, and ii) the spewing out of water due to excess pore water pressure induced in the liquefied layer. The inflow of water from the lower liquefied layer increases the water level by 1 m or less if the thickness and the volumetric strain of liquefied layer is several meters and about 5%, respectively. The water spewed out from the liquefied layer occasionally reaches a few meters above the ground surface, but it flows through narrow spaces, such as cracks in the ground, and lasts for a short time. Therefore, the ground water level usually increases by only a meter or so. Considering this increase in the water table due to liquefaction, a water table of about 2 to 3 m below the ground surface must be the critical depth to prevent damage to a house, as schematically shown in Figure 22.

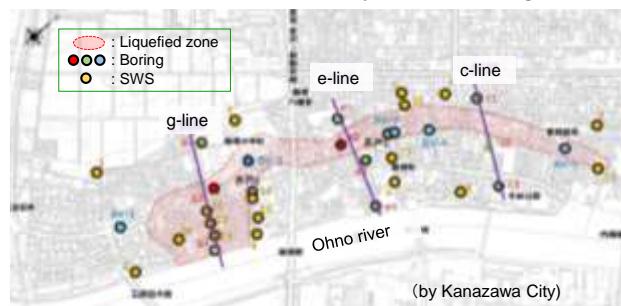
Fig. 30 Liquefied zone & locations of soil investigations in the Awagasaki district, Kanazawa City [KCDATRC, 2024]

Figure 30 shows liquefied zone and locations of soil investigations conducted approximately eight months after the earthquake in the Awagasaki district of Kanazawa City [KCDATRC, 2024]. Figure 31 shows the soil cross-section estimated based on the results of these soil investigations. As shown in this cross section, a layer of loose dune sand is deposited on the surface. Plans are underway to conducting 3D analysis of groundwater flow and to determine the layout of an effective network of underground drainage pipes for lowering the groundwater level as schematically shown in Figure 32.
