## **SEISMIC PERFORMANCE ASSESSMENT OF REINFORCED CONCRETE STRUCTURES WITH MASONRY INFILLED PANELS. THE CASE OF BLOCK # 22 OF THE SANTA MARIA HOSPITAL, IN LISBON**

### **ABSTRACT**

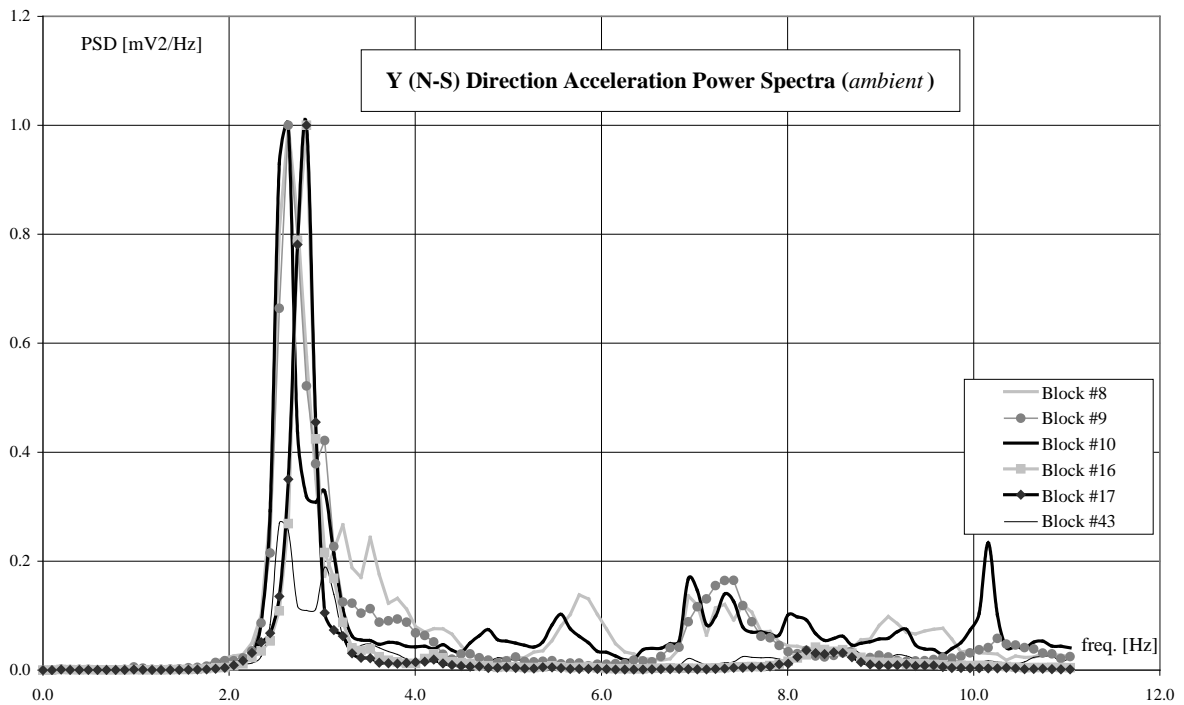
Fig. 3 Normalized ambient vibration acceleration power spectrum for building blocks #8, 9, 10, 16, 17 and 43 (Y - N-S direction)

2. The *simplified* modal identification is based on the assumption that ambient vibration excitation can be considered equivalent to a white-noise process, in which the peaks of the response power spectral density (or of its Fourier transform) correspond to the modal frequencies. Figure 3 depicts the normalized Y-direction (N-S) acceleration power spectra for ambient vibration records collected in building blocks #8, 9, 10, 16, 17 and 43.

3. These results (and others not shown) clearly point out to a unified behaviour of the building blocks with a fundamental frequency value of 2.4-2.8 Hz for X (E-W) direction and 2.4-2.8 Hz for Y (N-S) direction.

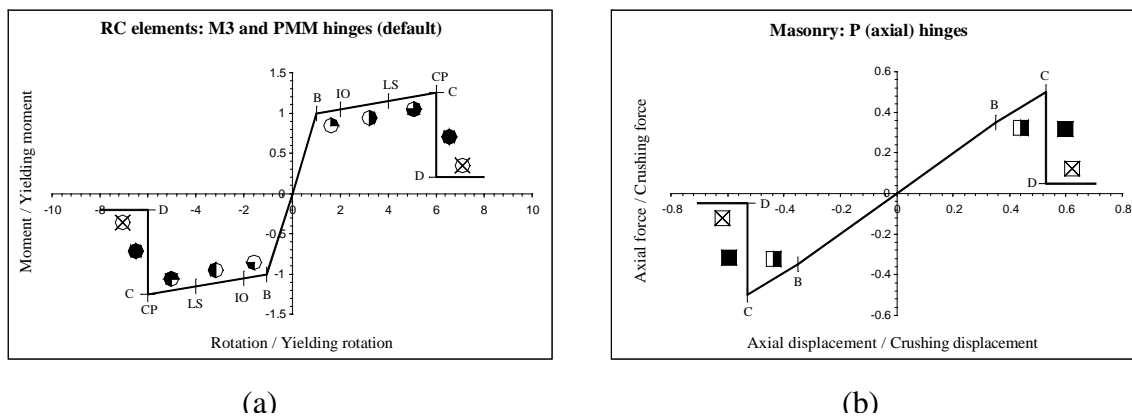
Fig. 6 (a) Concrete hinges (damage symbols); (b) Masonry hinges (damage symbols).

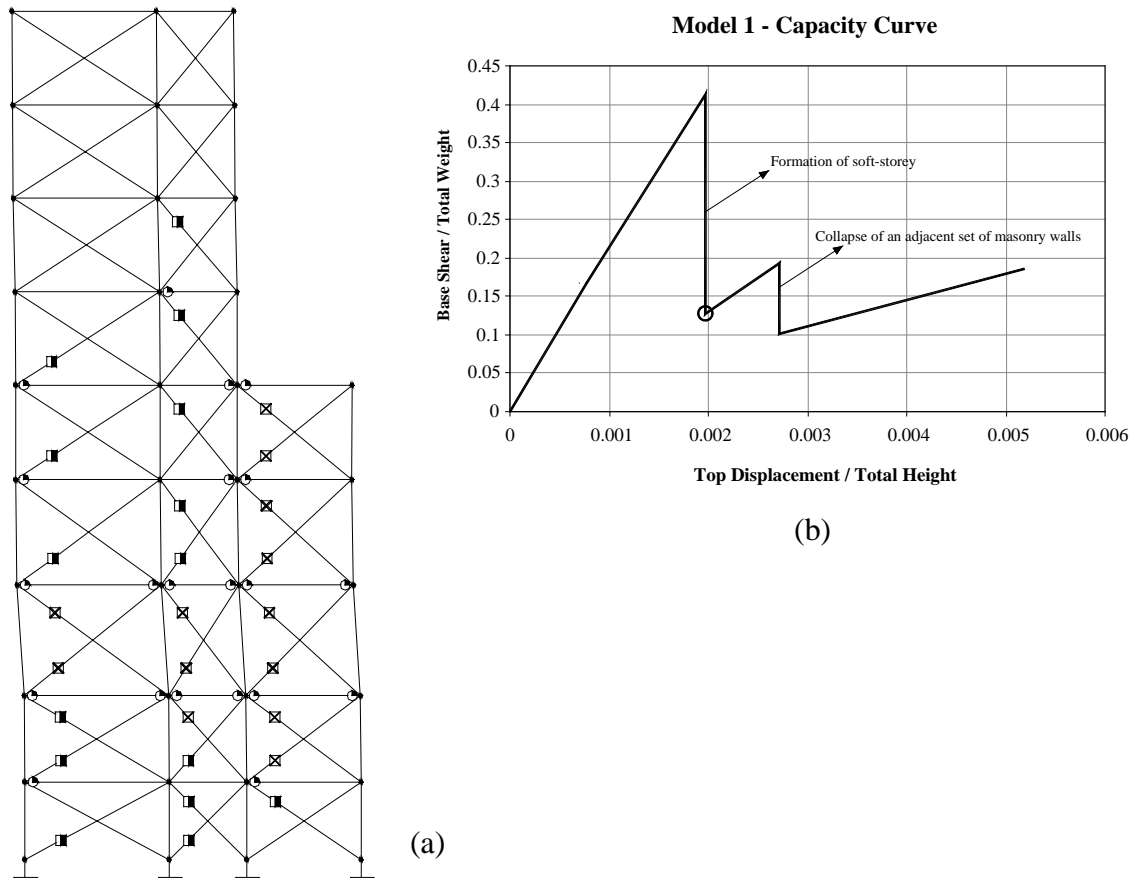
Fig. 7 Model 1 – (a) Layout of damage at the instant of soft-storey formation (for damage symbols refer to Figure 6); (b) Capacity Curve based on first mode loading

As referred previously, the lateral load pattern applied along the building height was based on the elastic fundamental mode. The increments of this lateral load pattern led to the capacity curve presented in Figure 7 (b) in terms of the normalised base shear *vs* drift. This curve shows the yielding, cracking and crushing sequence of the various elements: as expected, the masonry elements are the first to crack – the three top storeys are the least affected, while the lower ones present generalized degradation. For increasing top displacement values, damage tends to concentrate at the intermediate levels (2<sup>nd</sup>, 3<sup>rd</sup> and 4<sup>th</sup> storeys), and, for a drift value of 0.00198, all struts at the 3<sup>rd</sup> storey reach their ultimate strength. Further loading increments result in the development of the well-known soft-storey phenomenon. Figure 7 (a) shows the damage inflicted both in the masonry and in the reinforced concrete elements, at this step, even though, as previously described, these two structural elements are considered to exist in different parallel planes. More masonry elements at other levels have also reached their ultimate capacity at the onset of the soft-storey mechanism. The damage in the RC elements is limited to yielding in some beams, especially those of the second and third levels.

The formation of the soft storey is the first noteworthy drop in the lateral load system strength (marked with  $\circ$  in the capacity curve of Figure 7 (b)) – the structure remains very stiff until the collapse of the intermediate storey infilled masonry set of walls. As stated, the analysis led to the formation of a weak 3<sup>rd</sup> storey, yet sensitivity analyses carried out afterwards showed that the soft-storey phenomenon can take place either in the 2<sup>nd</sup> or in the 4<sup>th</sup> levels, depending on the strength parameters of the diagonal struts. The critical role of the infill masonry walls leads to a sudden lateral strength degradation of over 65 percent. Crushing of these struts leads to a major transformation in the first mode shape and, consequently, also in the lateral load pattern that should be applied to the structure to evaluate its performance. Hence, this model is no longer valid for the subsequent structural assessment stages, and a new model had therefore to be developed.

In the 2<sup>nd</sup>, damaged, model all the elements that have attained their ultimate capacity (the diagonal masonry struts represented by  $\boxtimes$  in Figure 7 (a)) at the instant of the soft-storey formation are removed, as can be seen in Figure 9 (a).

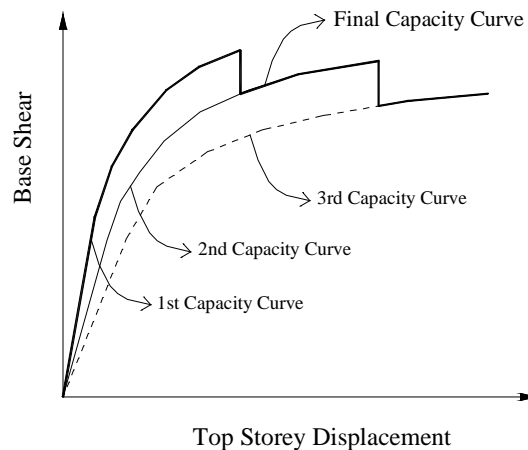
Fig. 8 ATC pushover curve, obtained from several capacity curves, as indicated in (Applied Technology Council, 1996)

At a certain stage in the lateral loading increments, it is likely that an element (or group of elements) starts to significantly lose its (their) strength. In such cases, new capacity curves have to be generated in order to model the overall loss of strength. It is convenient to reduce or eliminate the stiffness of the damaged element (or group of elements) and create the additional capacity curves to an accurate global structural characterization – the final composite curve is assembled from these different capacity curves. The transition from one capacity curve to the following is done at the displacement corresponding to the strength degradation of the first curve - the final pushover curve resembles a saw tooth shape, as shown in the generic curve of Figure 8, proposed by ATC-40 (ATC, 1996).

According to ATC-40 (ATC, 1996) and as previously clarified and generically shown in Figure 8, the final capacity curve is determined combining the different capacity curves at the displacement corresponding to each strength degradation, which is realistic provided that there is a limited strength degradation. For the actual building and soft-storey phenomenon this assumption turns out to be unacceptable – the reasons for this statement are explained later in this paper.

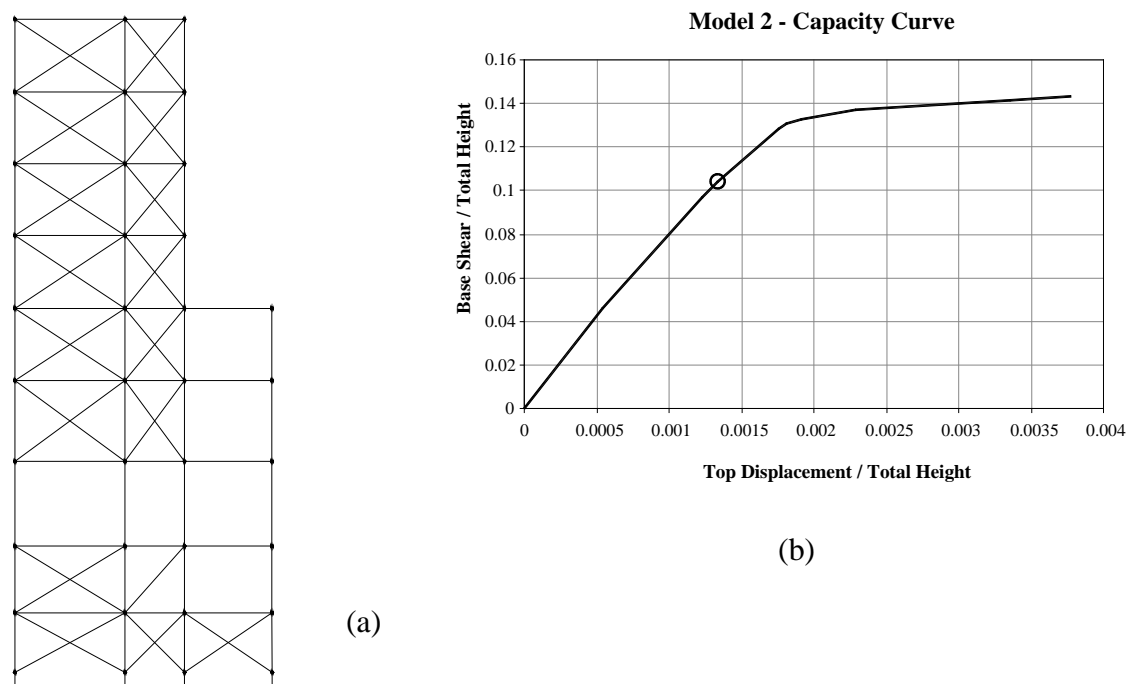
Fig. 9 Model 2 – (a) Removal of collapsed masonry struts; (b) Capacity curve based on first mode (for Model 2)

After running the pushover analysis with model 2 (whose capacity curve is shown in Figure 9 (b)), the first step consisted in the observation of the deformation distribution and progression throughout the elements. The high lateral forces applied at the soft storey level have led to large demands of deformation capacity in the column and beam elements in that vicinity. In contrast, all remaining RC elements are kept practically undeformed, without significant stresses, even for considerable drift values of 0.003 (top displacement of 0.10 m). The only masonry elements that were subjected to significant axial force increments are placed above and below the soft-storey, never reaching, however, the cracking strength for the same extreme top displacements values.

The point in the capacity curve of model 2 from which the structural system would continue to be represented was determined comparing the degradation of the reinforced concrete frames of model 1 (at the onset of the soft-storey mechanism) with the progressive degradation of the same components of model 2. In fact, there is a value of the base shear (marked with ○ in the 2<sup>nd</sup> capacity curve of Figure 9

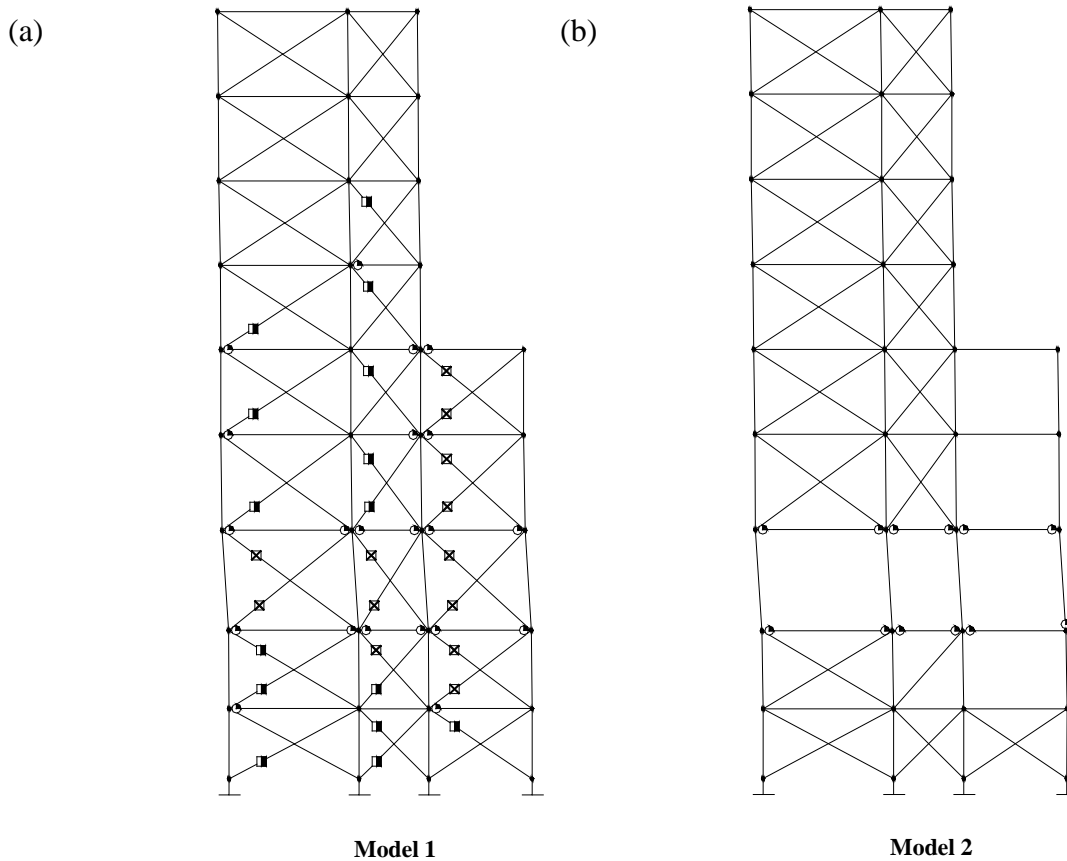
Fig. 10 Comparison of the “equivalent” stage between Model 1 and Model 2 (for damage symbols refer to Figure 6)

(b)) for which the deformation of the RC elements adjacent to the soft storey is reasonably similar to that of model 1 at the onset of soft storey mechanism (see comparison in Figure 10). This is the stage beyond which the final capacity curve of the structure should follow the capacity curve of model 2. It is clear that there is a significant number of differences between these two stages, making these two not totally “compatible”. Nevertheless, damage in the RC elements neighbouring the 3<sup>rd</sup> storey was by far considered the most important similarity to account for with care. In fact, the deformation of the RC concrete elements outside the 3<sup>rd</sup> storey is not crucial, since these are not subjected to subsequent high demands – i.e., the lateral displacement, after the soft-storey, is mainly due to the deformation of the columns and beams of this level. For the masonry, the most notorious discrepancy between the two compared stages are the several panels that had achieved the cracking strength in model 1 but that were modelled with the initial stiffness in model 2. This inconsistency can be, however, disregarded because the assumed post-cracking stiffness is almost identical to the initial one (see Figure 6 (b)). The key task left is precisely to find out whether the stress increment in the masonry elements of the level above and below the soft-storey is enough to cause their collapse (and consequently lead to new soft-storey formation) before the performance point is attained.

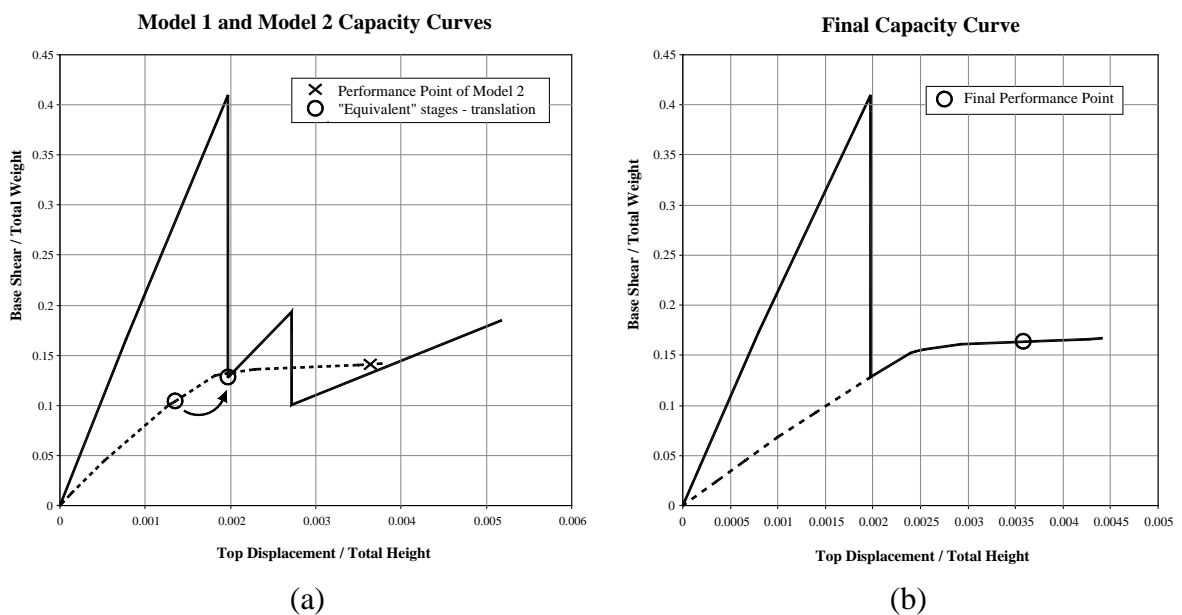
Fig. 11 (a) Capacity curve for each model; (b) Final capacity curve

The final capacity curve is obtained combining the first part of the capacity curve of model 1 with the second part of the capacity curve of model 2 (Figure 11 (a)). The result can be observed in Figure 11 (b).

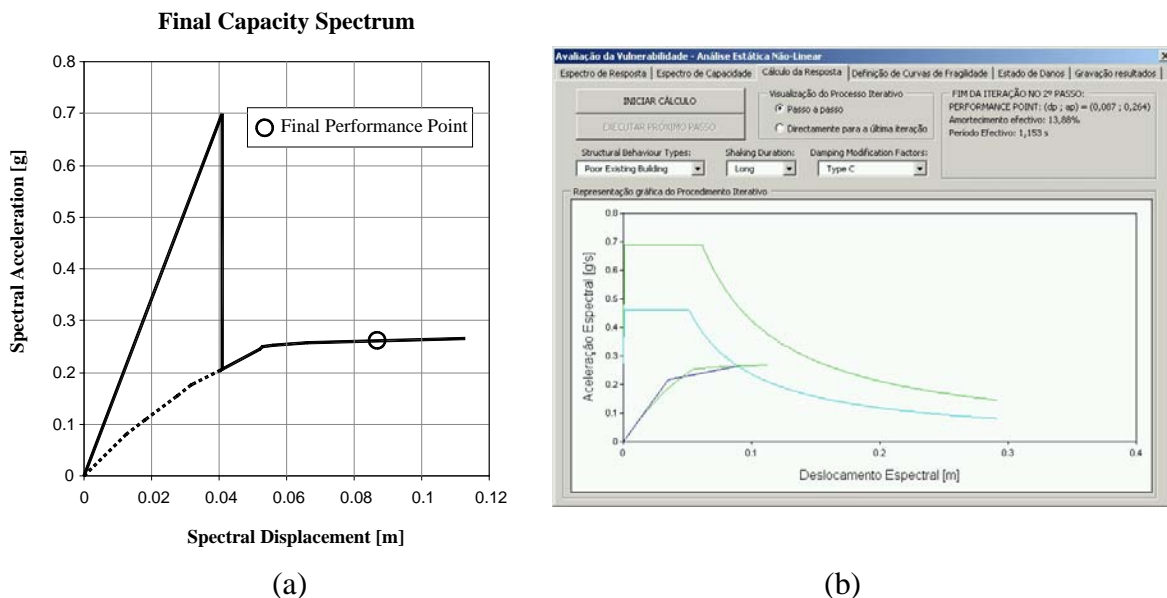
Fig. 12 (a) Capacity spectrum; (b) Performance point determination

Using all this information, it is now possible to determine the demand, for which the steps indicated in *Procedure A* of ATC-40 (ATC, 1996) are followed. The conversion of the capacity curve to the capacity spectrum is depicted in Figure 12 (a). The remaining steps of the procedure were implemented in a graphical/numerical computer programme, specifically created for this task (see Figure 12 (b)). This program has the following particular features:

The performance point (PP) resulting of this method is, in spectral coordinates, (0.264 g; 0.087 m) which, in terms of normalised base shear vs drift represents a demand of (0.1638, 0.0036). The corresponding base shear and top displacement values are, respectively, of 7979.98 kN (1726.5 kips) and 0.1153 m (4.53 in.). The final base shear is composed of 6007.08 kN of model 1 and only 1672.9 kN of model 2. It should be noted that the equivalent viscous damping is 13.88 %, for a period that has lengthened from an initial value of 0.488 s to 1.153 s.

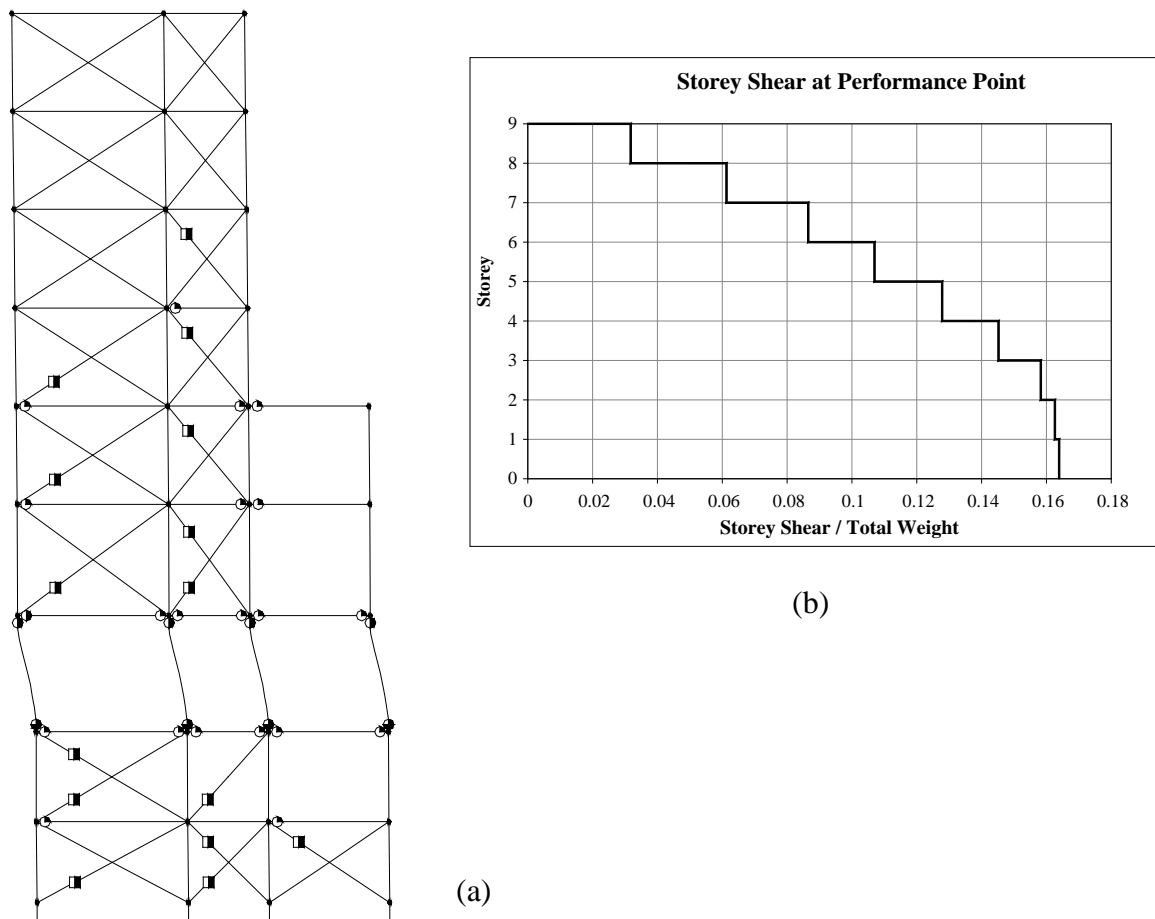
Fig. 13 (a) Expected damage description for concrete and masonry at performance point; (b) Storey shear (for damage symbols refer to Figure 6)

storey. Plastic hinge formation at PP can be observed in Figure 13 (a), which was assembled from results of model 1 (for concrete elements outside the soft-storey and masonry) and model 2 (for concrete elements adjacent to the soft-storey).

As can be seen from Figure 13 (a), although the risk of life-threatening injury is not negligible, some margin against total or partial structural collapse remains. Figure 13 (b) shows the storey shear distribution for the calculated demand.
